## Window glass – replacing a curved rear window

Tom Jones

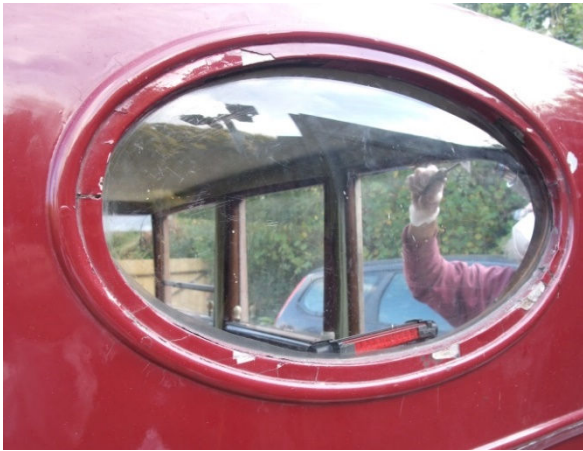
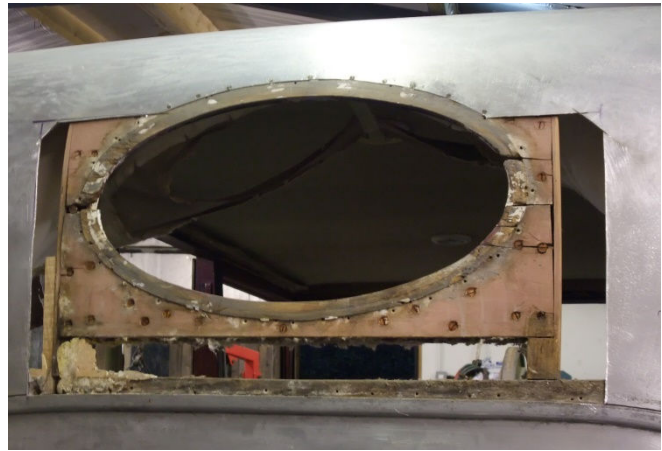
The wood frame surrounding a window is sometimes damaged by water seeping between the glass and the frame. After all, our cars are nearing 100 years old. Not until my 1927 Hooper GXL39 was being stripped for a bare metal respray did I notice that the wood frame was beginning to rot, see photograph. I also noticed for the first time that the rear oval window

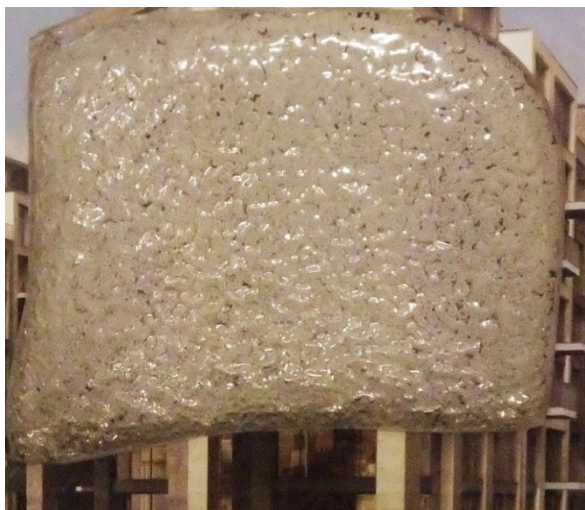
After researching on the internet and experimenting with our kitchen Aga oven, I succeeded in making an acceptable window. The process is quite exacting: first the polycarbonate must be heated to about 115°C for a several days to remove water (the Aga was most useful here). Water is a by-product of the polymerisation reaction and remains dissolved in the solidified plastic. If the water is not removed, it will form steam bubbles when the plastic is heated to the higher temperatures needed for bending: the plastic then becomes opaque, see photograph, left.

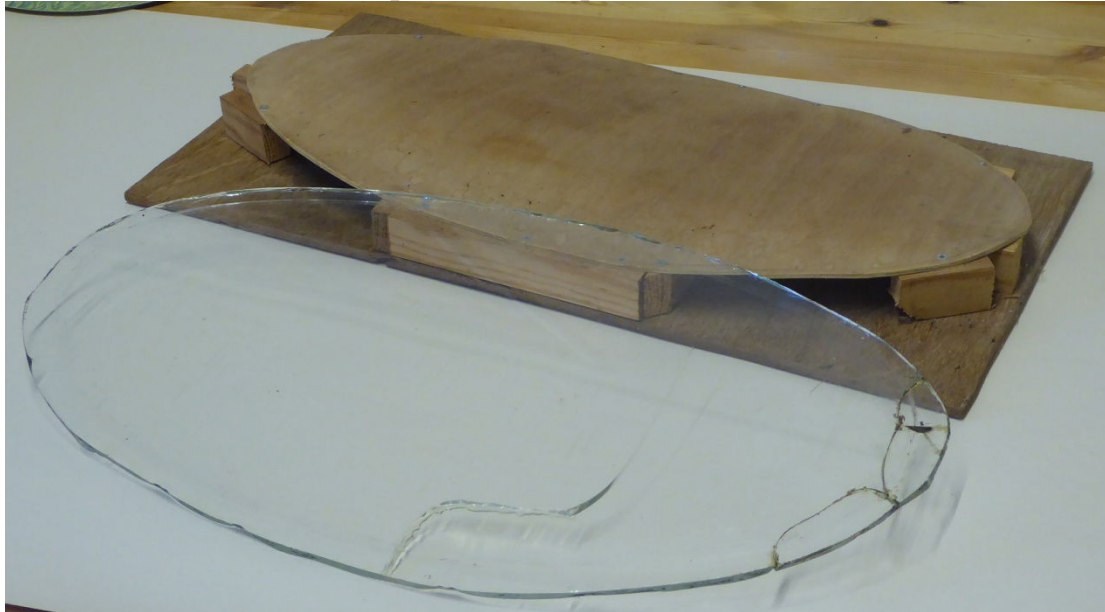
**Old glass and wood former for shaping the polycarbonate**

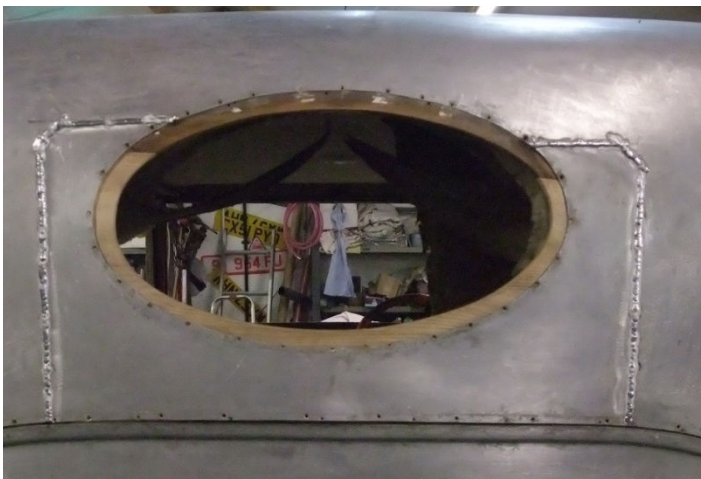
**Repaired rear window frame – outer**

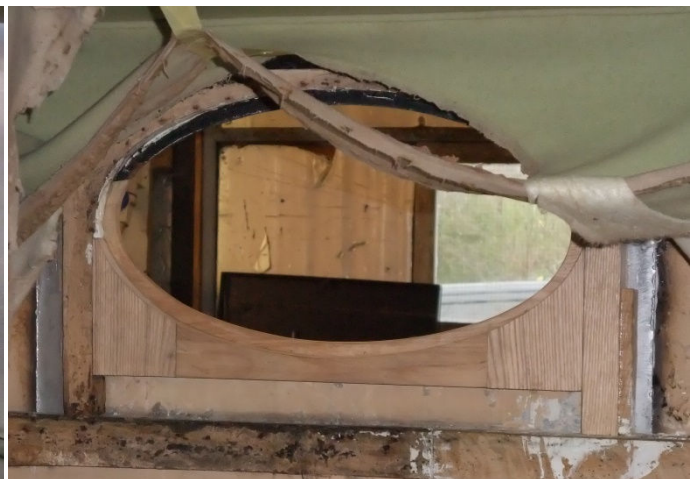
**Repaired rear window frame - inner**
