## Autovac Nut Replacement

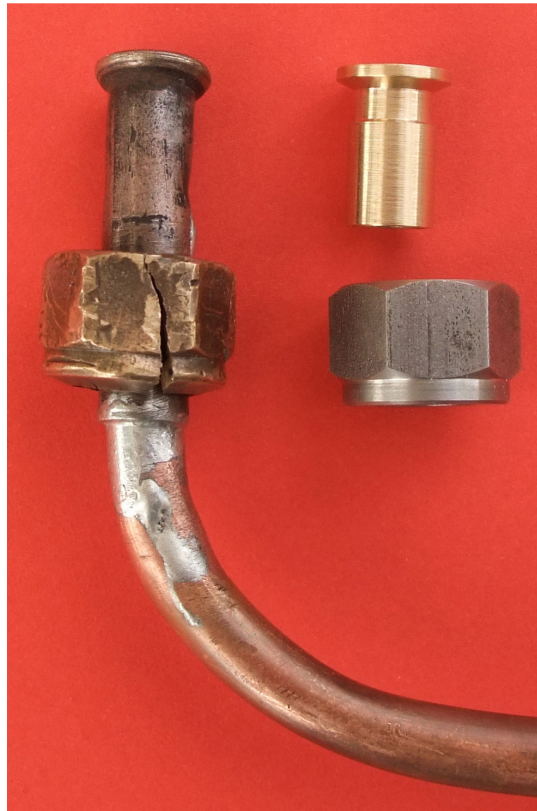
If your Autovac weeps petrol it may be because the large brass nut holding the petrol delivery pipe to the base of the Autovac is cracked, see photograph. (This is a CEI nut, Cycle Engineers Institute, later rationalised into British Standard Cycle with essentially the same thread profile. It has 26 threads per inch and requires a 7/16" BSF spanner.) This cracking is a common problem because the base of the nut is expanded when it is tightened onto the ferrule.

The Autovac Company supplies replacement nuts, nicely made from stainless steel, together with ferrules. [www.autovac.co.uk](http://www.autovac.co.uk) [info@autovac.co.uk](mailto:info@autovac.co.uk) 01299 251628

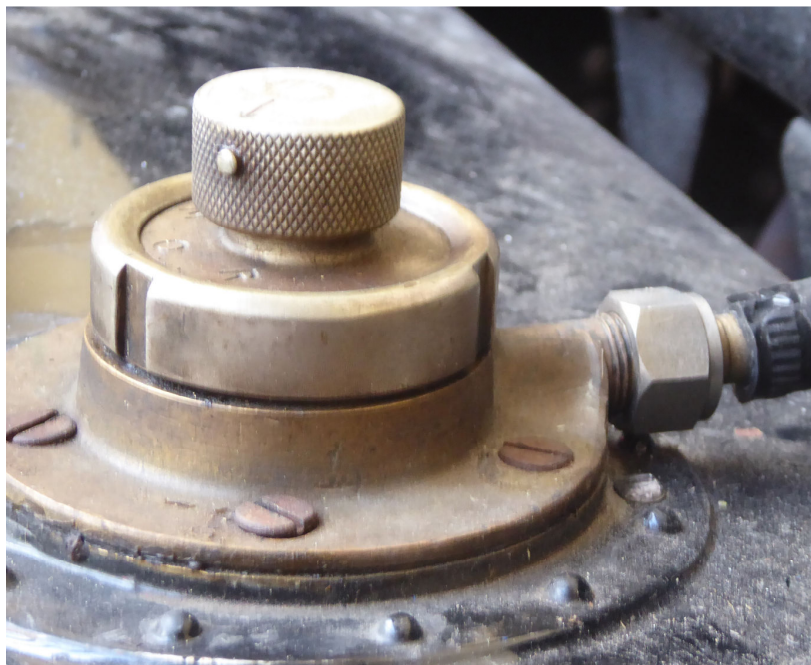
Exactly the same nut is used at the other end of the petrol pipe to attach it to the top of the petrol tank, see Figure.
