Repairing the Ignition Switch

Rolls-Royce devoted much care to the design and development of the ignition switch for the instrument boards of their 40/50hp and 20hp chassis, but then, Sir Henry started his career as an electrical engineer. Two internal RR memos referring to the design of the switchbox are reproduced in **Appendix 3**.

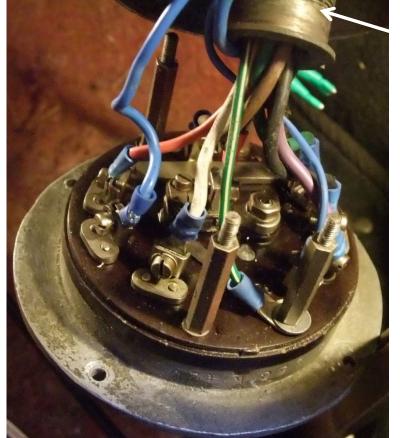
1

- Remove the switchbox from the instrument panel
- Remove four nuts holding the rear aluminium cover in place, push cover away from switchbox and up the helical conduit (1), exposing all the wires leading to the switchbox, **Figure 1**

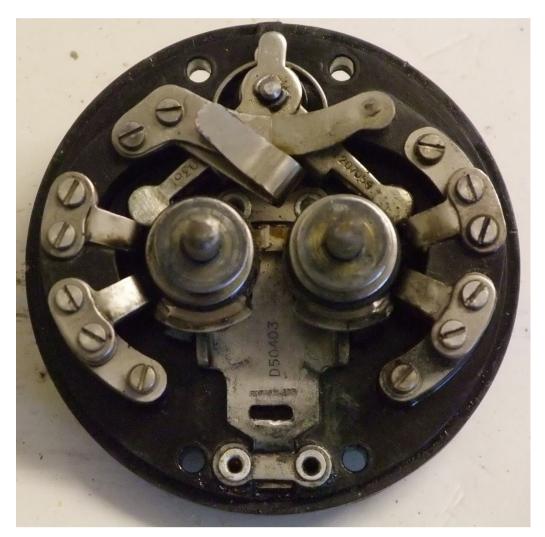
Figure 2

- Label each wire and note which terminal each wire is attached to
- Release all wires and take the switch box to the work bench, or the kitchen table (much warmer)
- Remove the two switch handles (but not the instrument light switch. Remove the remaining long spacer nuts which hold the Bakelite base to the aluminium front face. Note that one spacer nut is shorter than the rest
- Separate the Bakelite base from the front face. This is a tight fit, and it might be difficult to start the separation. Gently tap a Stanley knife blade into the joint around the circumference until it starts to open up a crack
- Revealed: the beautiful, solidly-built switch box mechanism, probably covered with a layer of dark brown oily stuff, **Figure 2**
