How to avoid the grease staining of your pre-war engine.

Allan Fishburn has come up with an ingenious, yet simple solution. Replace the original Rolls Royce designed packing with a modern hydraulic seal.

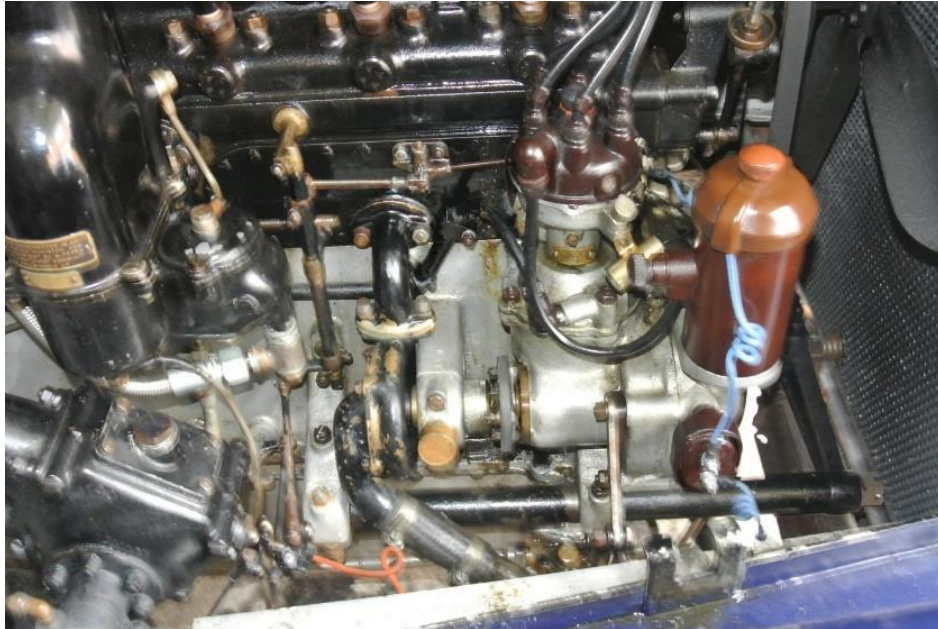
Originally the water pumps used two types of packing, a square graphite type, this comes in straight lengths, the packing is moulded round the shaft and then cut to length. The second packing type uses a string like gland packing; this is simply wrapped round the shaft until the desired thickness is obtained. The seal I used was supplied by "simply bearings.co.uk" it is a 0.5x1x0.25 inch Nitrile Rubber Double Lip Rotary Shaft Oil Seal with Garter Spring R23/TC Style.

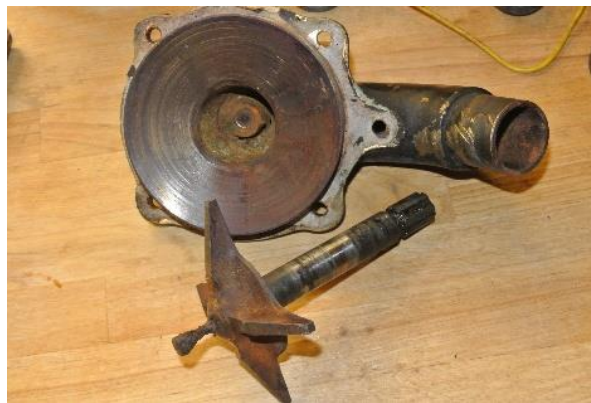
Hopefully there is not any internal wear or damage and you can proceed to change the seals. As you can see from the below picture of my pump the shaft and impellor were worn and had to be replaced.

Once the body is split, all will be apparent. If the impellor is worn or damaged, or the shaft is scored, these items will have to be replaced with new before proceeding to change seals.

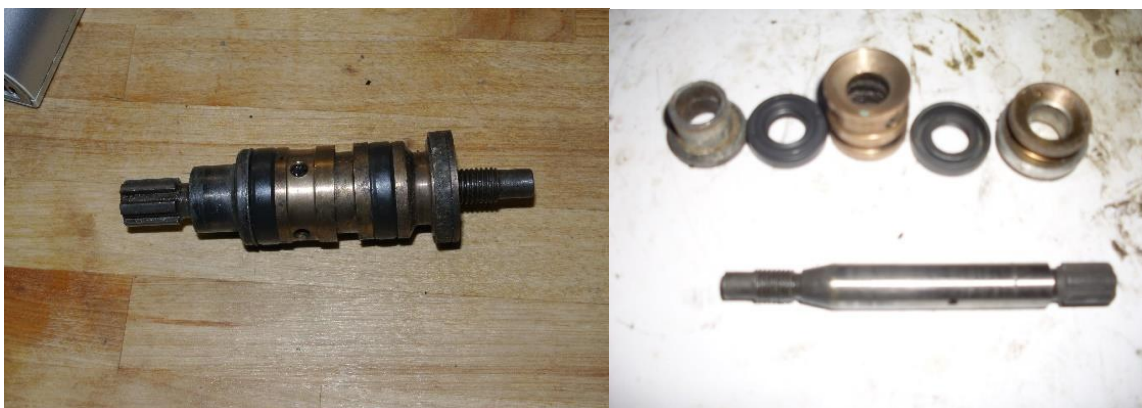
The above pictures show the new seals on and off the drive shaft. The orientation of the shaft on the first picture, should be the other way around.

The bushings and the new hydraulic seals can be assembled on the shaft using a good helping of water pump grease. Insert the shaft into the pump, then screw on the left-hand threaded impellor.
