## Starter Switch – Maintenance and Repair

## Rolls-Royce starter switch 20hp and 20/25

# Starter Switches

FOR 20hp AND 20/25hp

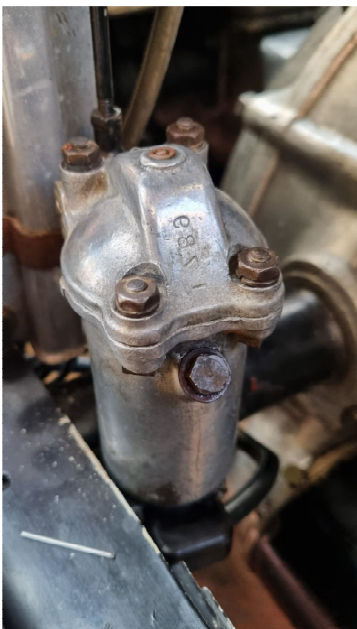
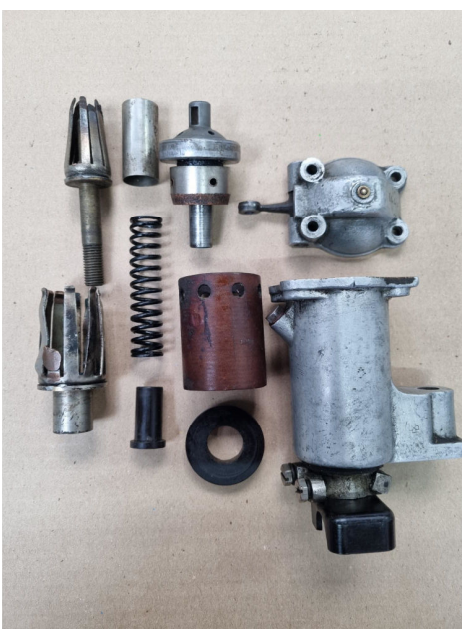
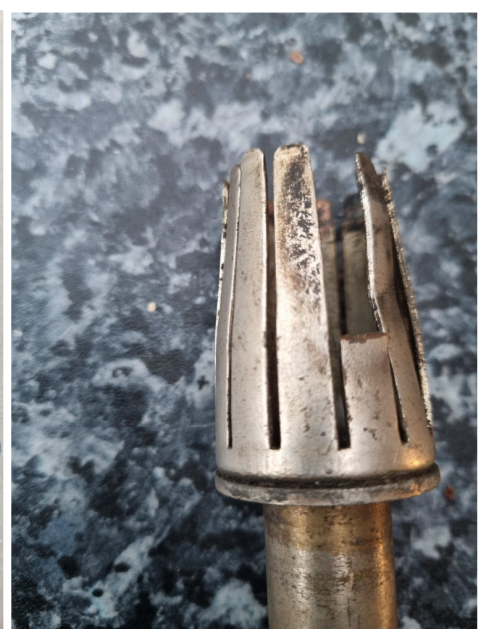
During an annual service, remember to check and top up the starter mechanical solenoid with oil to keep the contact tips cool during contact engagement. The oil breaks the circuit when the switch is opened and without the oil the contacts do not always break the current flow because an electric arc forms between the contacts; oil quenches the arc that forms when the contacts are open.

If you have not had the assembly removed and dismantled, or have no records of it being dismantled in the past, it may be time to consider doing so before you get in an embarrassing position with the starting of your engine. Check for broken, distorted or burnt contact fingers – check before you get caught out!

Room for thought – some of these cars are now 100 years old – preventive maintenance is the answer so check and top up with oil!

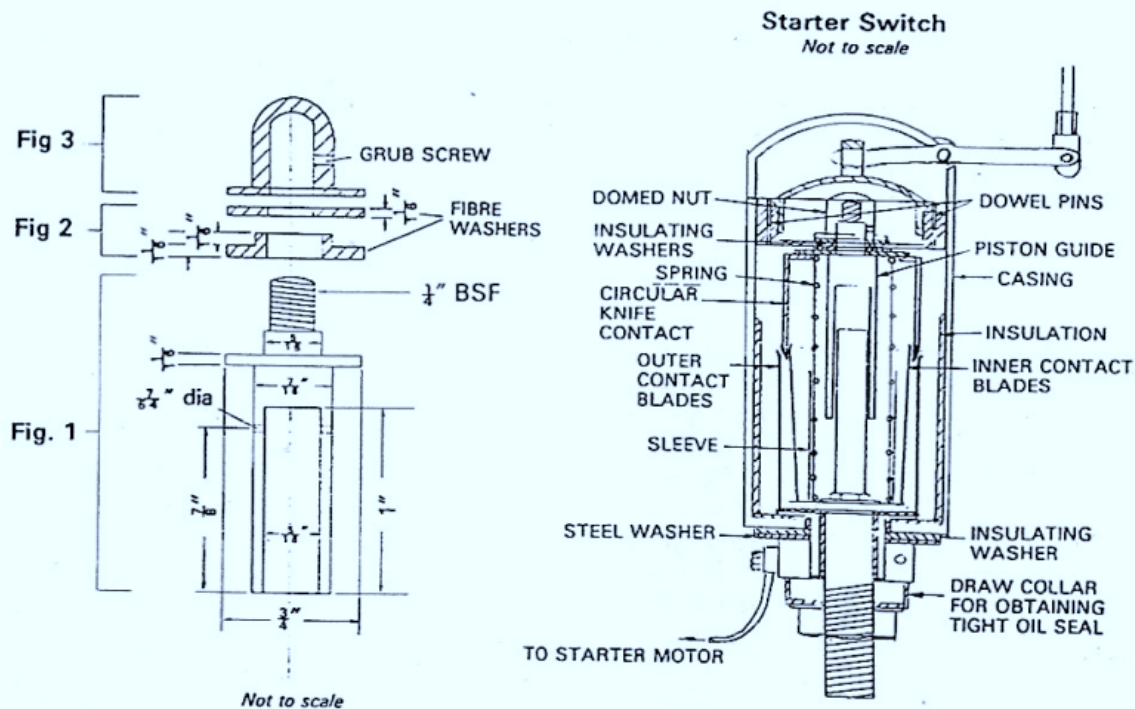
It was at this point that I had to work out the best way to restore the switch to working order. I decided the only way was to machine up a new contact guide assembly. I made this from a piece of  $\frac{3}{4}$ in diameter bright mild steel bar to the dimensions shown in figure 1. The next thing was to make two insulating washers, as shown in figure 2. I then made a domed nut with combined washer, figure 3, to hold the contact guide assembly together. This I locked with an  $\frac{1}{8}$ in grub screw through the side, plus a touch of Locktite. While the knife contact was stripped out I machined the bevel on the leading edge just enough to clean it up.

The secret of getting the switch to work was to tighten the domed nut to give an end float of 0.01in, leaving the knife contact free to float, so as to automatically centralise when the switch is depressed. After making sure that the casing is clean inside and out, the outer set of contact blades can be pushed back in place with a little smear of Wellseal on the underside. Next replace the inner set of contact blades. One of the problems I have experienced with various Rolls-Royce cars over the years has been the leakage of oil from the base of the starter switch, requiring constant vigilance of the oil level. To obtain a good oil tight joint at the base I replaced the insulating ring with a smear of Wellseal between it and the casing, then the metal washer, next the terminal clamp ring, lightly nipped in its correct position, i.e. terminal facing front of the car. I then machined up a draw collar, placed it over the terminal stud and against the clamp ring. Replace the nut and tighten firmly against the draw collar. This will pull the whole assembly together. Now tighten the terminal clamp ring locking bolt, remove the nut and draw collar. Now fit the Bakelite insulating cover with the cut out piece the right way round to suit the direction of the battery cable.

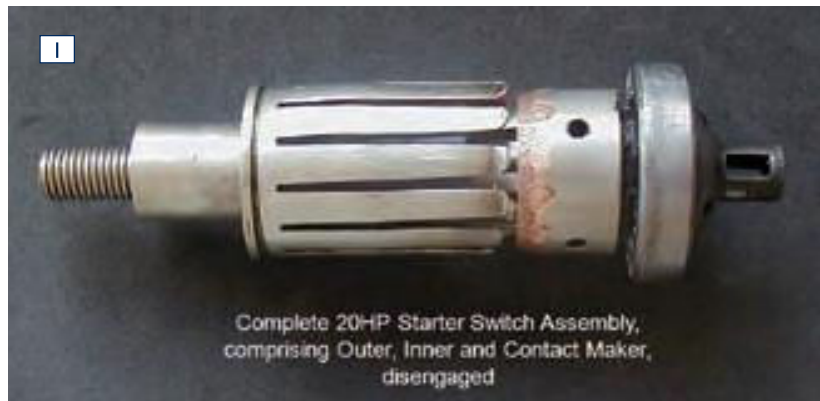
The switch was removed from the car and the contacts already removed from the casing. Picture 1 shows the assembled switch, showing burnt contacts, some shorter than others, together with the burnt Contact Maker. The Contact Maker is insulated from the chassis earth by tufnol insulators. The Inner and Outer Contacts are insulated from each other by a tufnol tube. This will need to be gently eased out of the

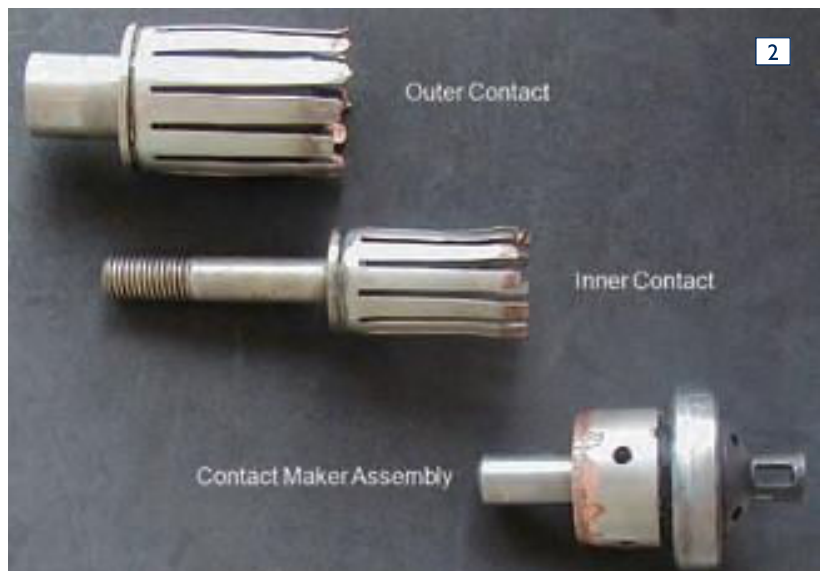
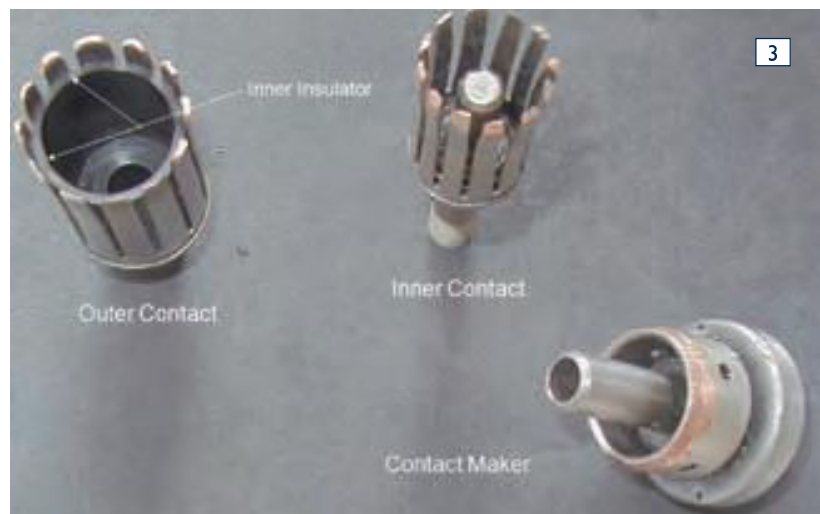
contacts. This is fragile and must be treated with great respect to avoid breakage. Pictures 2 and 3 show the contacts separated. The damage caused to the contacts is clear to see.

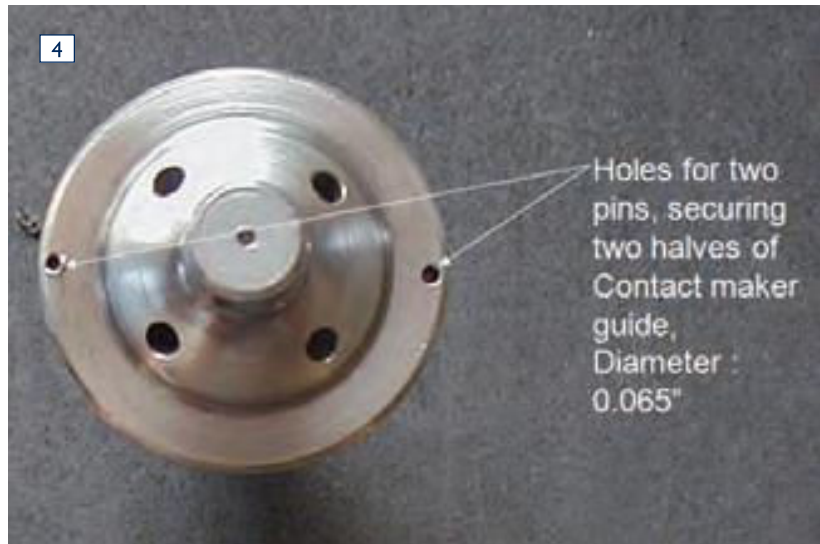
Picture 4 shows the upper face of the Contact Maker Guide. The guide is an assembly of several parts, housed in a two-part housing, screwed together, and locked in place by two small pins. These need to be removed, either by a small punch or drilled (0.065") to enable the Contact Maker to be removed. Picture 5 shows the guide housing with the pins having been removed and the two halves unscrewed from each other. Picture 6 shows the guide disassembled, the inner nut removed, (normally locked by a single centre punch indent to the thread), allowing the component parts of the guide to be removed, including the Contact Maker. On reassembly, I chose to use Loctite and a centre punch indent to the nut.

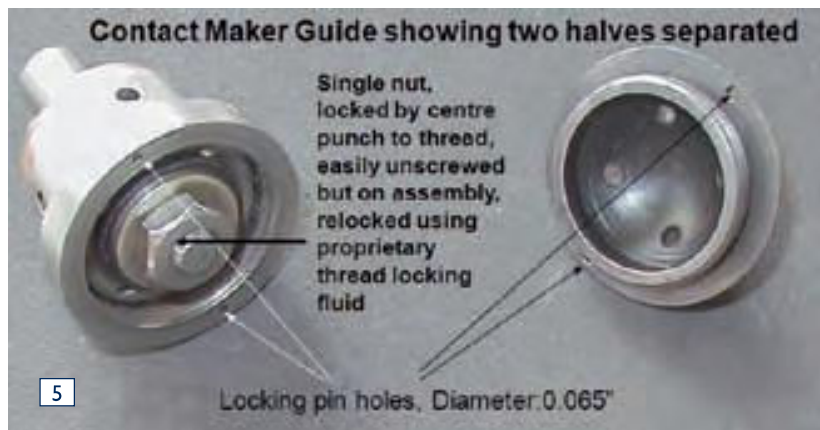
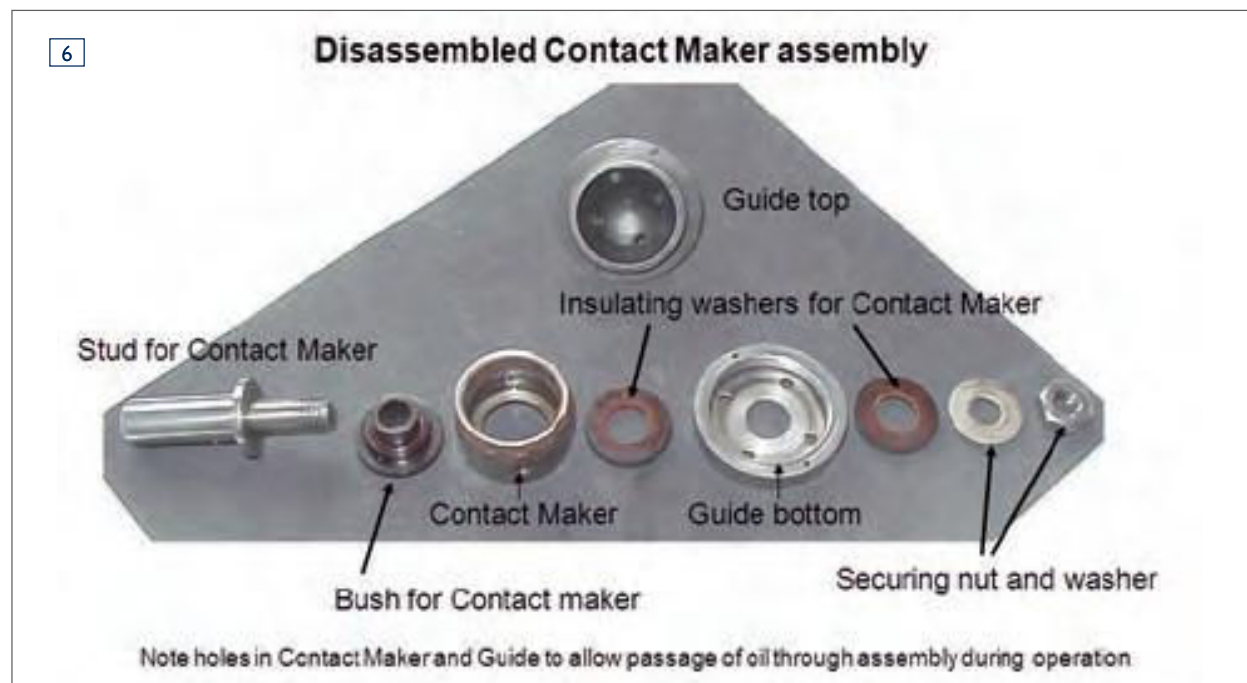
Picture 7 shows the Inner and Outer Contacts and the degree of damage to the shape and length of the contacts. Measure the length of the shortest finger of the outer contacts. Deduct this length from a finger which appears to be the least damaged. In this case, the difference was 0.1 inch. Very carefully either file or lightly

grind the remaining fingers down to the length of the lowest finger, ie. 0.1" off the inner fingers and 0.1" off the outer fingers. This will give the effect of the fingers being equal in length on the inner set, equal in length on the outer set but with a difference between inner and outer of  $\frac{15}{16}$ ". Originally the overall length of the Inner Contact was  $\frac{3}{2}$ " and  $\frac{29}{16}$ " for the Outer Contact. The difference, ie.  $\frac{15}{16}$ ", must be achieved after careful dressing of the fingers.

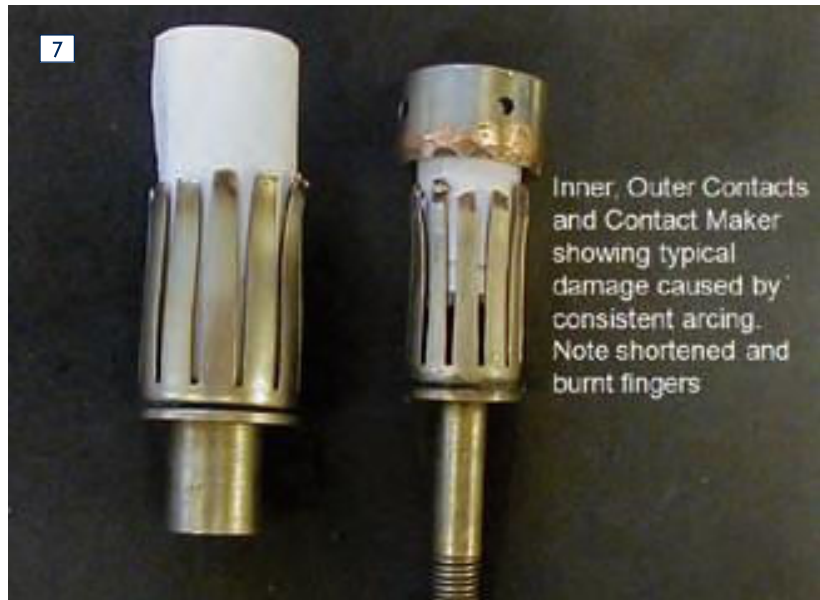
Picture 8 shows the fingers of both Inner and Outer Contacts all shortened by 0.1" and reshaped to allow smooth engagement of the Contact Maker. The Contact Maker was replaced by a slightly longer version, increased by the same amount as had been removed from the fingers, in this case, 0.1". The inner insulator was also shortened by 0.1".

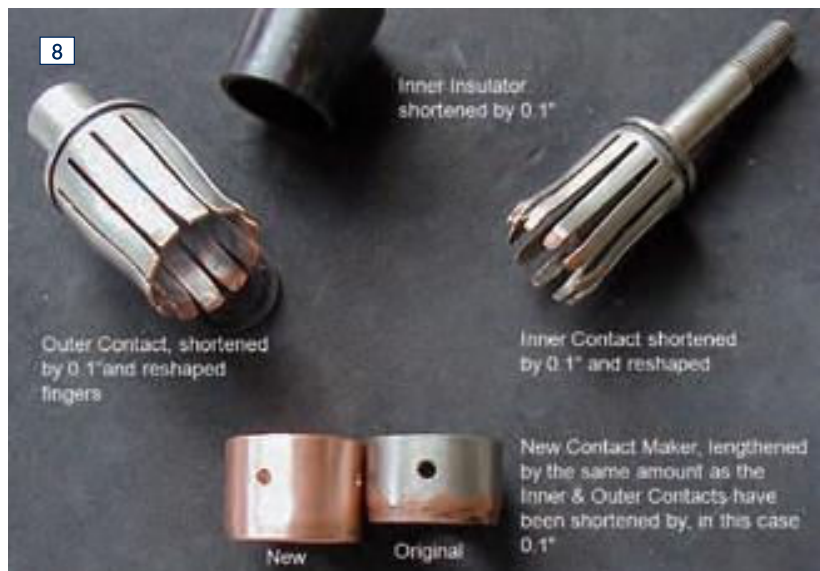
Picture 9 shows the switch with the inner and Outer Contacts even in length, with the inner set protruding such that the Contact Maker engages with those first, then with the outer set. The Contact Maker is replaced on the stud, supported by the insulating pieces.

The finished switch is now repaired to allow good operation; the modification to the Contact Maker only lowering the point of contact within the switch, not externally. After the switch is replaced within the housing, care must be taken to ensure good electrical insulation from the chassis, as all the internal components are live relative to the chassis. Cleanliness is paramount as any small amount of swarf or other debris could result in complete discharge of the battery at that location, inevitably causing serious damage or a fire. Do not underestimate the need for cleanliness.
