## Window glass – replacing a curved rear window

Tom Jones

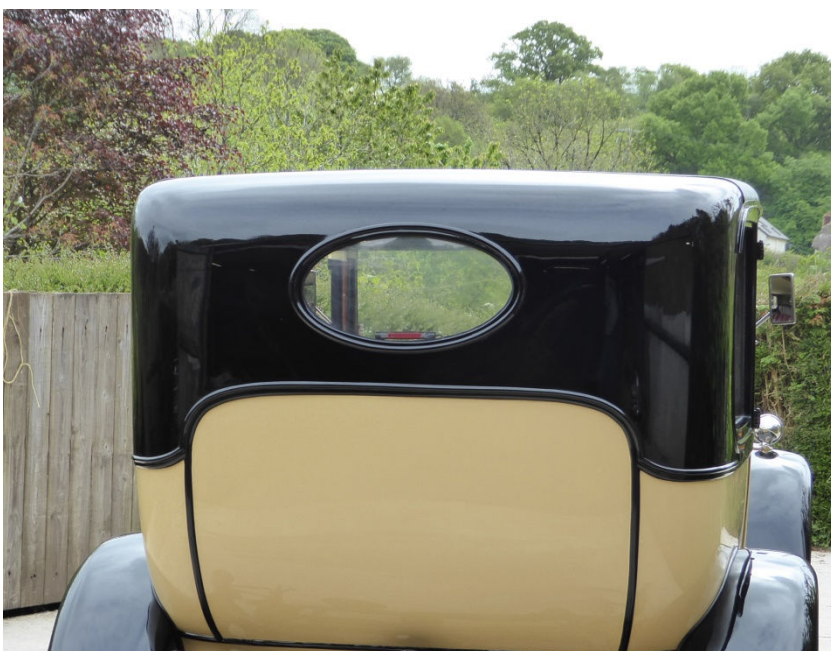
After cooling to room temperature the inside curved surface was not quite perfect because of the texture of the plywood. I could have repeated the exercise using polished stainless steel for the curved surface, however I decided to remove the roughness from the inside surface using a professional glass polishing kit that I borrowed.

The result was nearly perfect and fitted the rebuilt window frame exactly!
