**CAUSES OF POOR PERFORMANCE IN THE 20HP
(with some application to later 20/25HPS)**

CHECK LIST

Compiled by Simon Slaffer

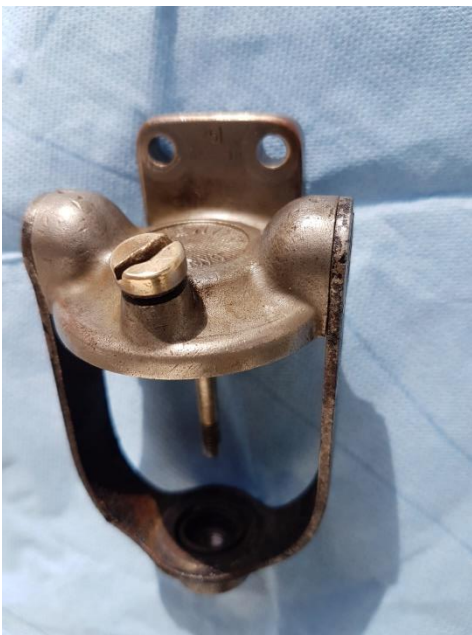
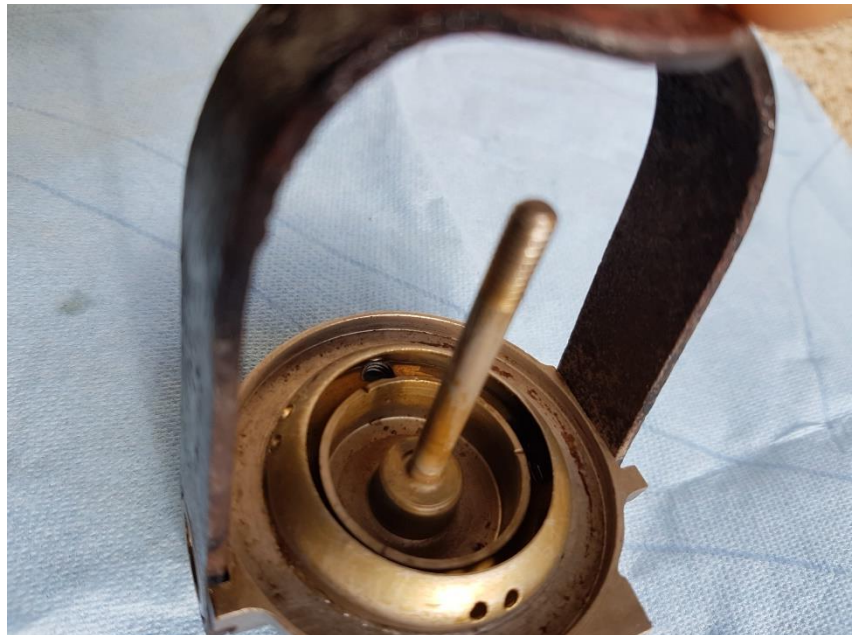
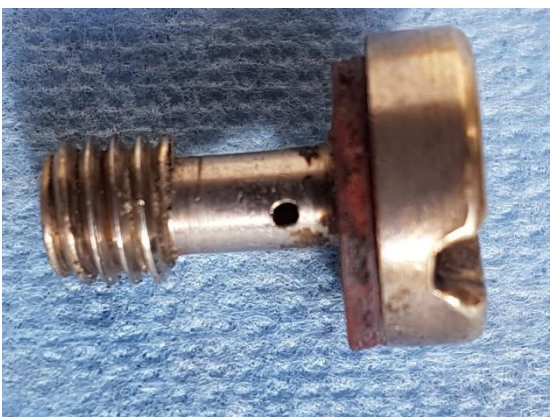
The Zenith petrol filter, fitted to the firewall just below the steering column from GXL October 1927.

Blocked air valve in petrol filter (see Appendix)

Unless it is absolutely necessary I would not advise removing the bracket off the firewall as it is very awkward.
