Reviving my Maimed Goshawk

By Hamish McNaught, a 20 year old Electrical and Electronic Engineering Student

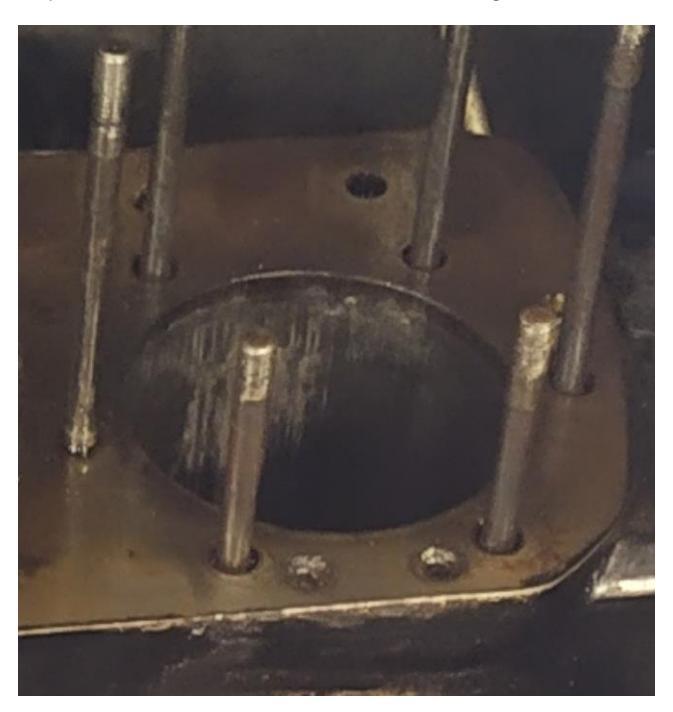
Upon removing the cylinder head (about a 4 hour job for anyone interested in changing a Small-Horsepower head gasket), there was an abhorrent amount of metallic deposits all over cylinder one, and there was scarring about 1.5mm deep in the bore, as shown below:

The vertical lines of lighter colour are where the piston rings have scraped the honed layers of cast iron away, most likely due to the aluminium piston expanding and the cast iron cylinder contracting. This metallic deformation was most likely caused by intense friction due to the lack of oil, which could have been washed away by steam circulating under a failed head gasket. Further, when localised friction occurs, a hot-spot is created which is where the majority of deformation occurs, hence the scraping on the bore.

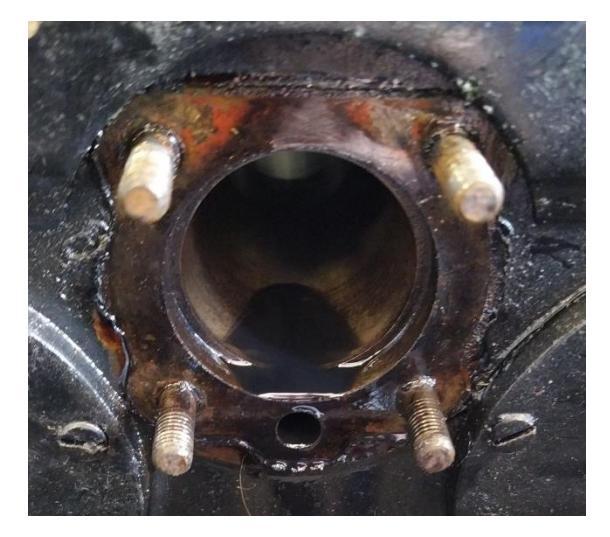
Another tell-tale sign of piston ring failure could be seen when removing the carburettor from the offside of the block:

The oil deposit seen in the aperture of the intake tube. Obturation should occur within a fuel-air intake system, although this gas tight seal (how the vacuum suction effect is created) has failed, and oil has been pushed up into the intake manifold by cylinder number 1. The spark plug on cylinder 1 was also covered in heavy black oil, indicating further failure in obturation.

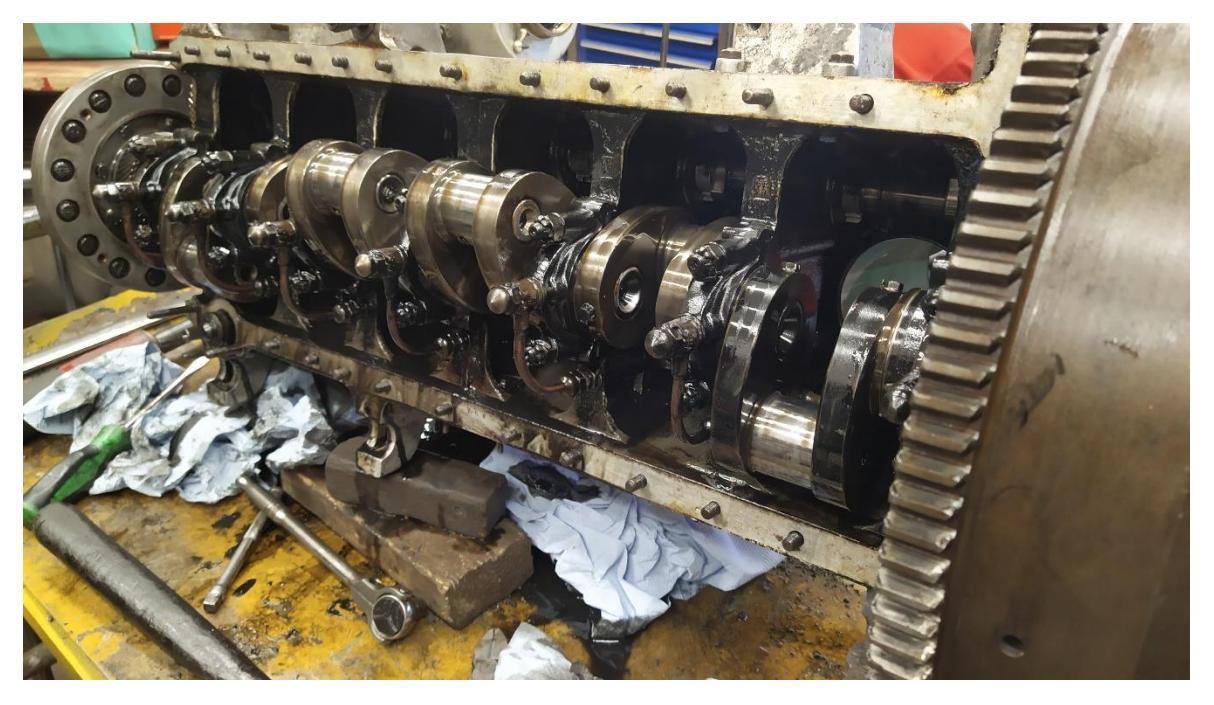
The pipes feed oil to each of the main bearing caps, which is ingenious because it minimises the risk of the bearings pinching on the crankshaft, which has disastrous consequences. You will also note the infamous crankshaft vibration damper, which was one of R's masterpieces.

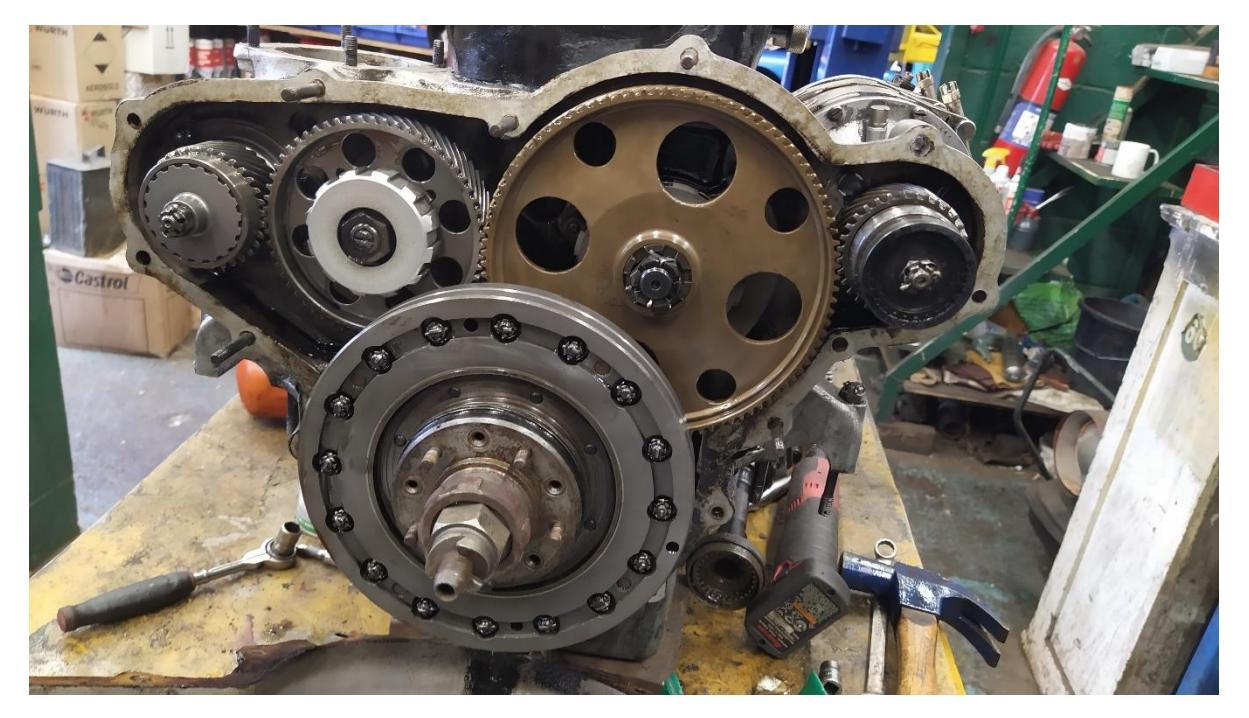
Here is the front of the small-horsepower engine. Again, this design was highly advanced and also bomb proof, because there are no chains or belts to fail. Just gears with the integrity of mill wheels! You can see why Lawrence of Arabia said that a Rolls-Royce was worth more than rubies in the desert, just look at how advanced this looks for a 100 year old design.

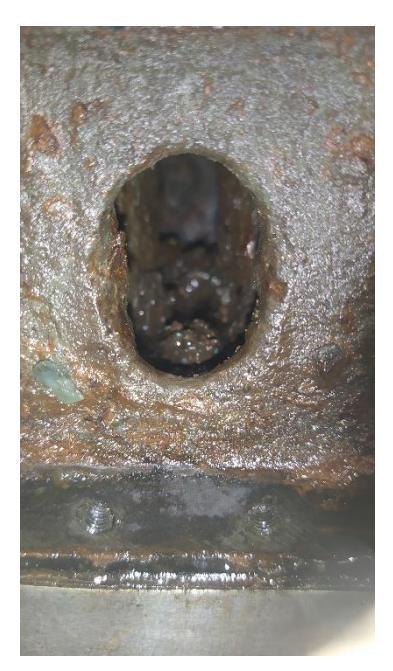
This image demonstrates the build-up of calcium, magnesium, rust and various crud from the radiator core. If one uses deionised water with a 50/50 mix of coolant (blue) then the likelihood of this corrosion forming is significantly reduced. Mr Keuning also suggests flushing out the system twice a year, which is a good prevention procedure. In essence, it is vital to keep this water circulating and not stagnant. If the car is to be laid up, use a greater ratio of inhibitor in the system. The cost will inevitably be greater but your investment will be worthwhile in the long-run.

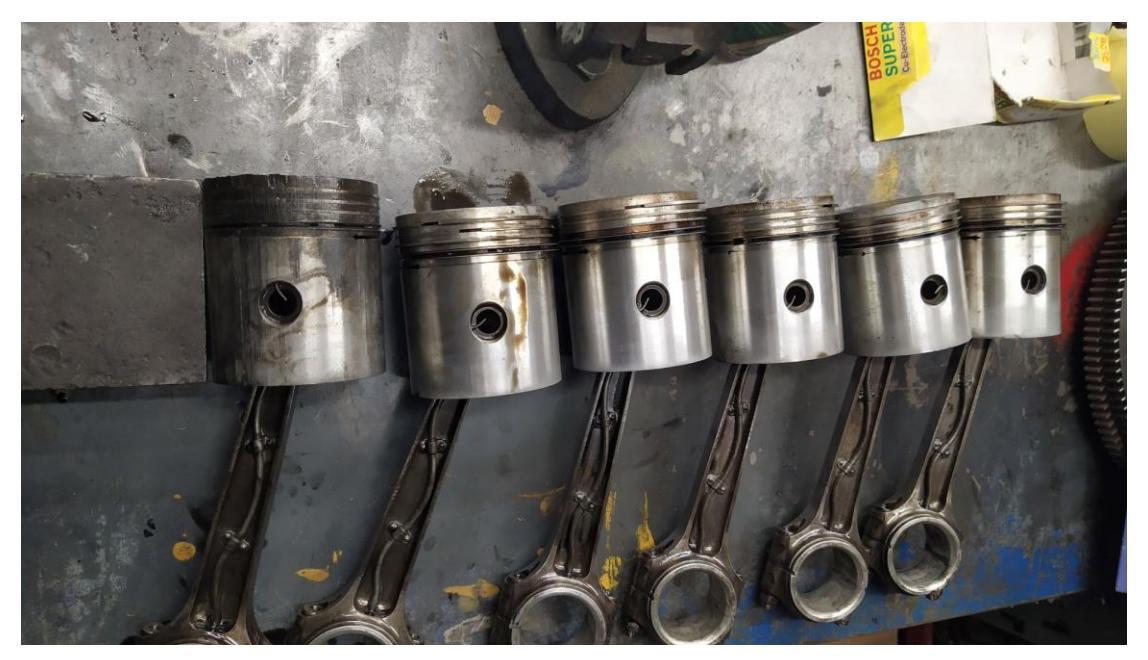
On the very left of this picture, one notices that the piston rings have fused themselves into the piston, and the leading edge of the piston is very heavily damaged. This only occurs during intense heat distortion within a cylinder. According to my own calculations, the temperature must have reached at least 660 degrees Celsius, as this is the point where aluminium warps.

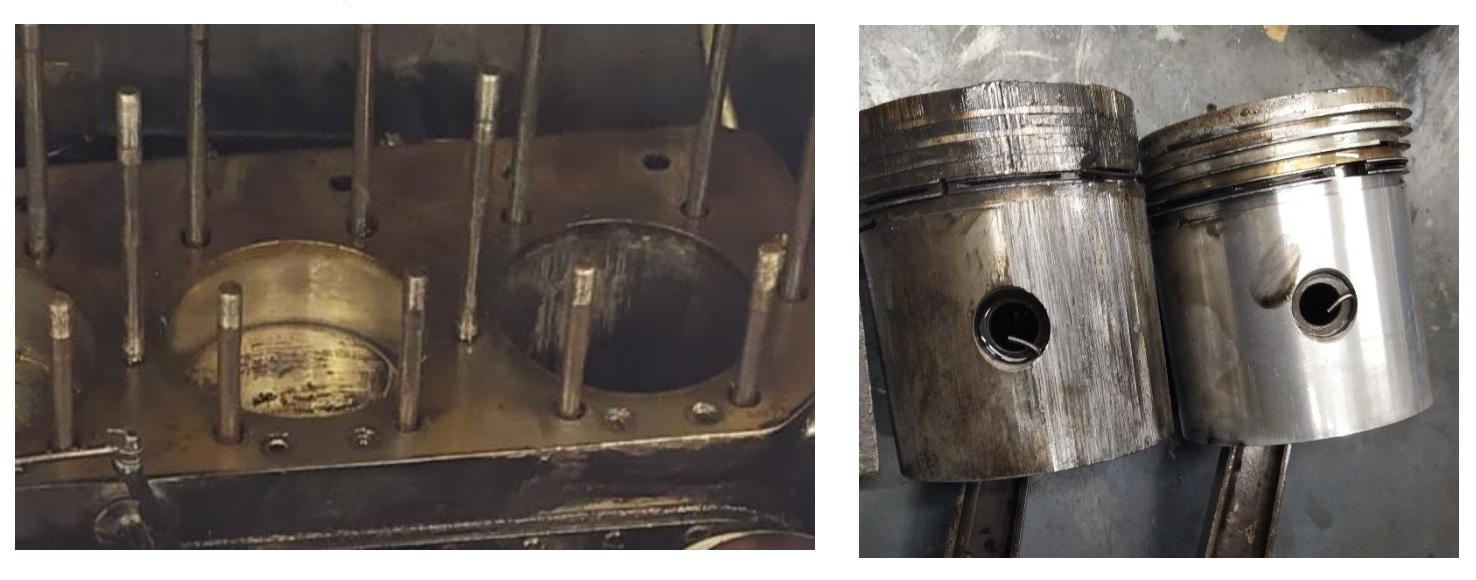
The photo on the left demonstrates what a bore should look like (perhaps slightly glazed) and a destroyed bore as a result of intense overheating.

The photo on the right shows the damaged piston next to a perfectly good piston. The contrast between the two is almost unbelievable.

Upon a thorough inspection, Richard and I were actually very surprised to discover that only two parts had been destroyed, those being the number one cylinder in the block and the number one aluminium piston. I have previously explained why this damage occurred, but I will share with you my critical, engineering analysis of what happened.

Eventually, we decided that the best idea was to re-sleeve the bores back to the original size for a number of reasons. Firstly, a sleeved block ensures that the block will last longer because you can always take away more sleeve metal if another rebuild is required in future. Furthermore, the sleeves ensured that we did not affect the structural integrity of the block, because we were not sure of how much cast iron we could remove before having too little material; the consequences of this may have been catastrophic because thinner metal is more likely to deform and cause failure again.

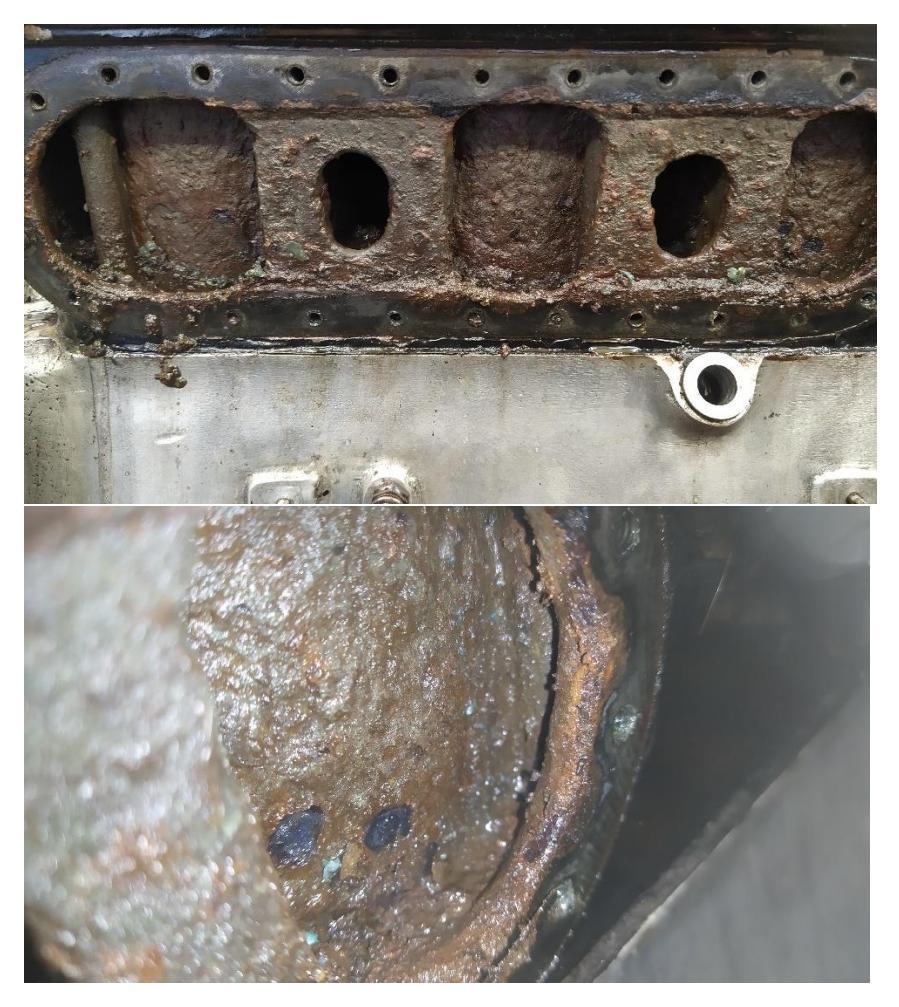
After removing the side-plates, I was presented with this absolute monstrosity:

The photos show the layer of corrosion that had developed all around the internal surfaces of the cylinder block, within the water jackets. This is a very common issue on Goshawk engines and I am sure that this is the cause of most engine failures generally on pre-war Rolls-Royce cars.

To remove the crud, I started by using a telescopic magnet which proved to be fantastic at removing the majority of the crud that was sitting in between the cylinders; I must have removed at least 8 lbs worth of material before even scraping the crud out. I then scraped out the crud with a blunt screwdriver and firm force, which then removed about 2 lbs worth of rust and corrosion.

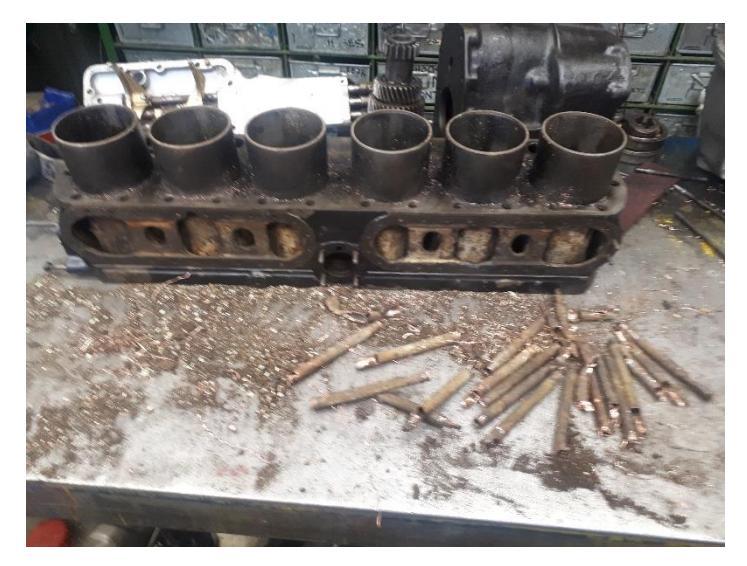
You can hardly tell that the pipes are made from copper! A scary demonstration of why you should always use an inhibitor in your coolant system, and flush it every sixth months.

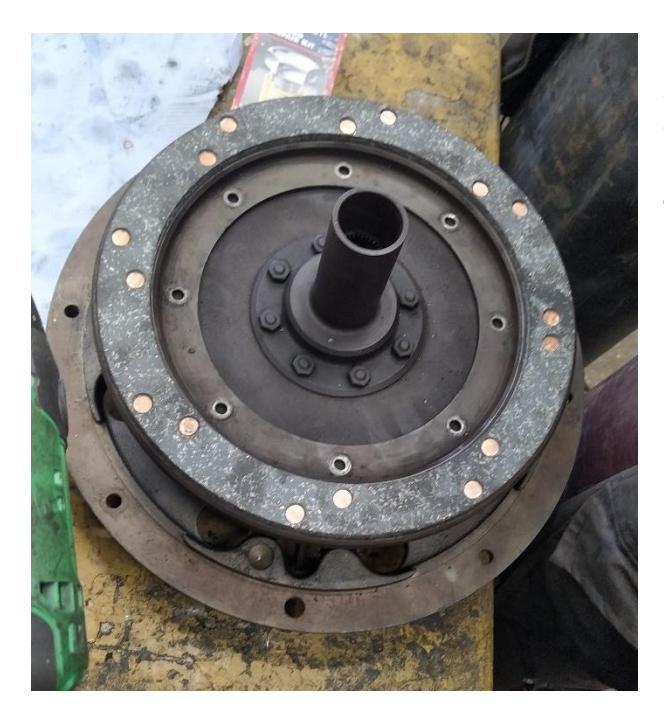
This is the lining from the flywheel carrier. It is imperative that the copper rivets sit correctly in the depressions of the lining otherwise your clutch will not work properly and the lining will disintegrate.

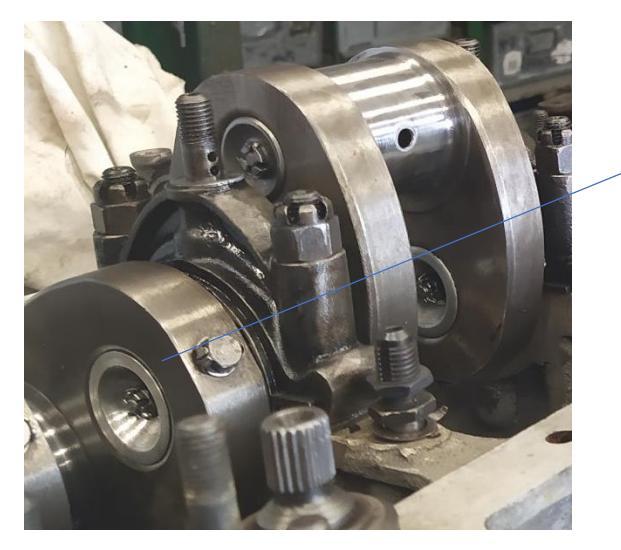
This is one of the many crankshaft sludge traps. It's job is to catch the thick and heavy oil contaminants which pass through the drilled oil holes on the crankshaft journals.

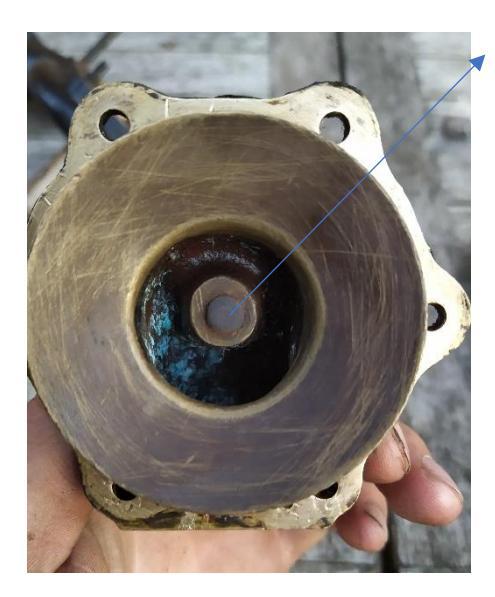
This central wooden 'stop' is made from lignum vitae, which is the densest wood known to man. It has selfoiling properties, which is why Royce used it to allow the impeller to spin against it.

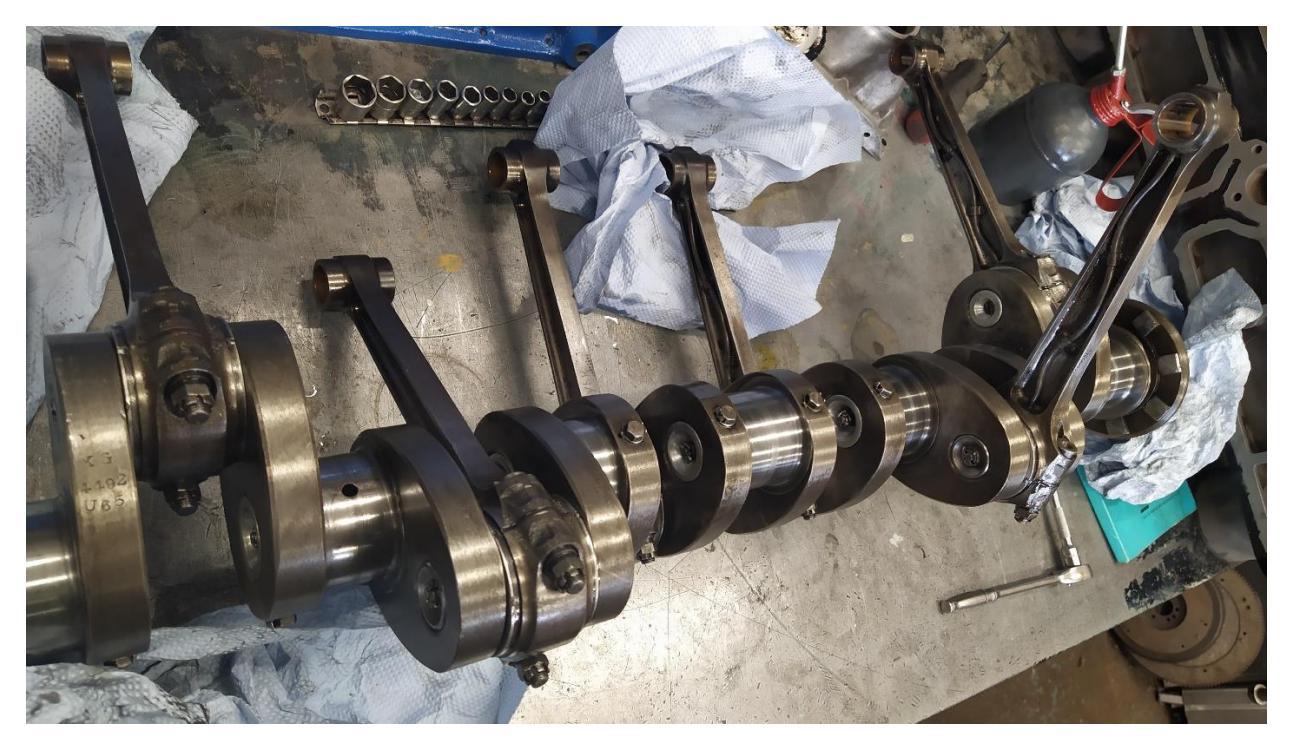
What I found fascinating was the presence of the original fitter's stamp on the far left journal web on the crankshaft, which reads "XG 4492 U65". My guess is that XG is the initials of the machinist, but not sure as to what the other two numbers could mean. On an unrelated note, some later 20/25s and Derby Bentley's have extra weights added to some of the journal webs to increase torque and rotational balance. The crankshaft weighs about 25 kilograms or half a hundredweight in old money.

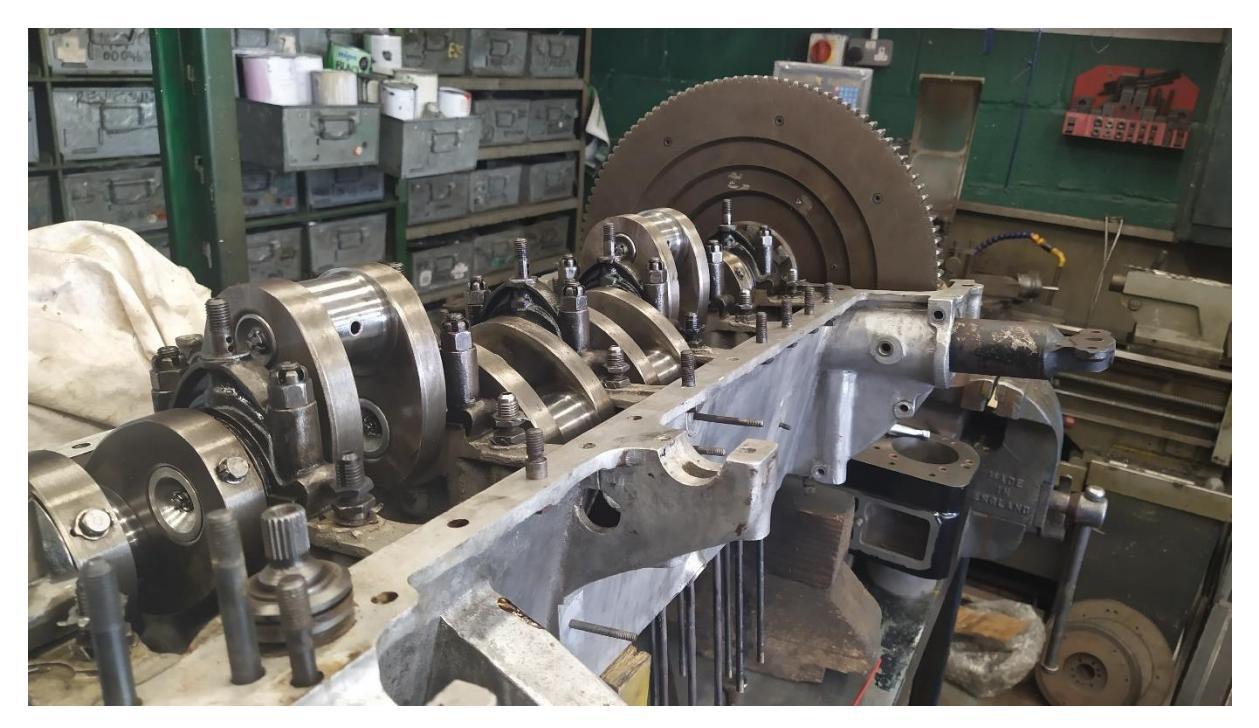
The crankshaft and flywheel now fitted together. If there are any tight spots in rotation, this is where you need to address the issues, which will most likely be a bearing pinching due to incorrect bearing nip calculations. Do not fit the oil pipes onto the main bearings until you are convinced that the assembly rotates perfectly. Please see my video on Goshawk Engineering to see how the flywheel should rotate.

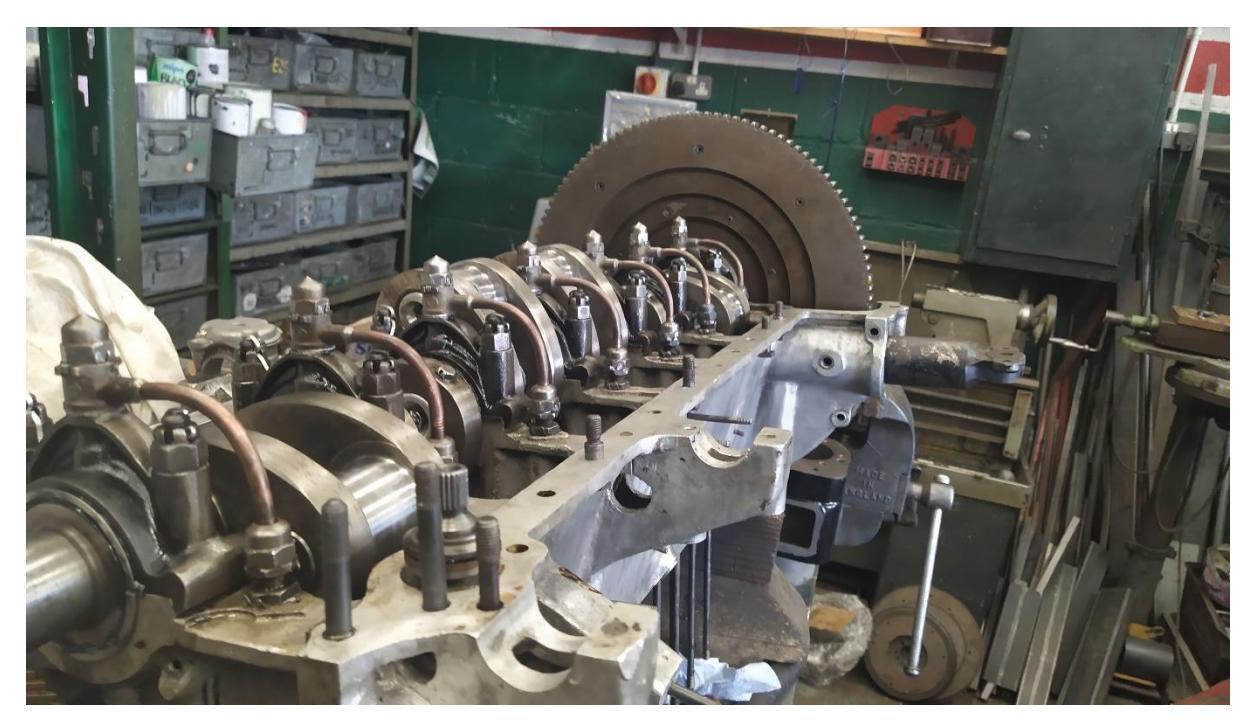
Main bearing oil delivery pipes fitted, with the caps tightened down.

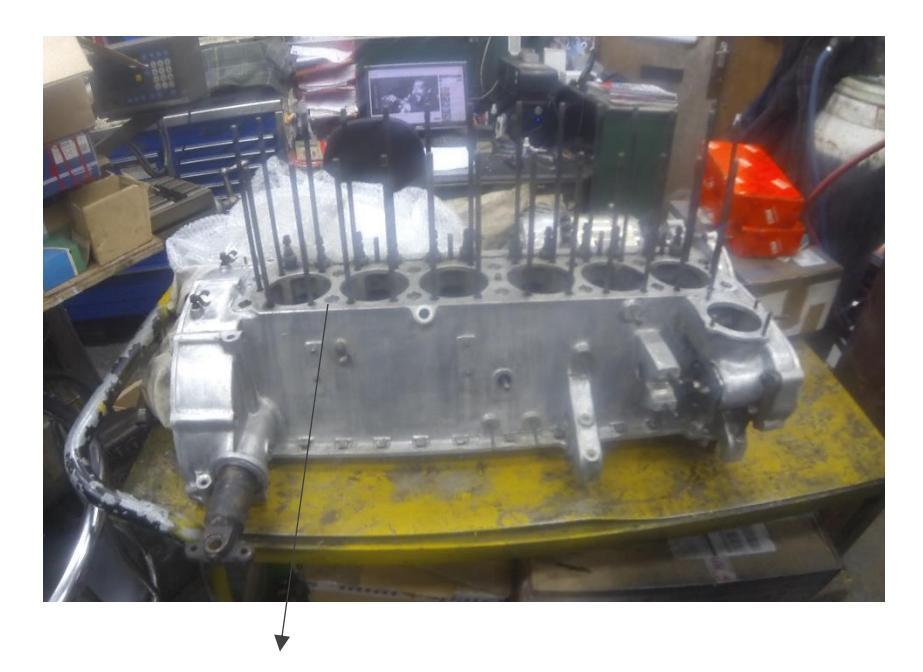
Prepare this surface with a razor blade to remove any old gasket material, then place a layer of Wellseal with your finger over all of this flat surface, before gently lowering the 'crankcase to block' gasket down on top of the Wellseal you placed with your finger.

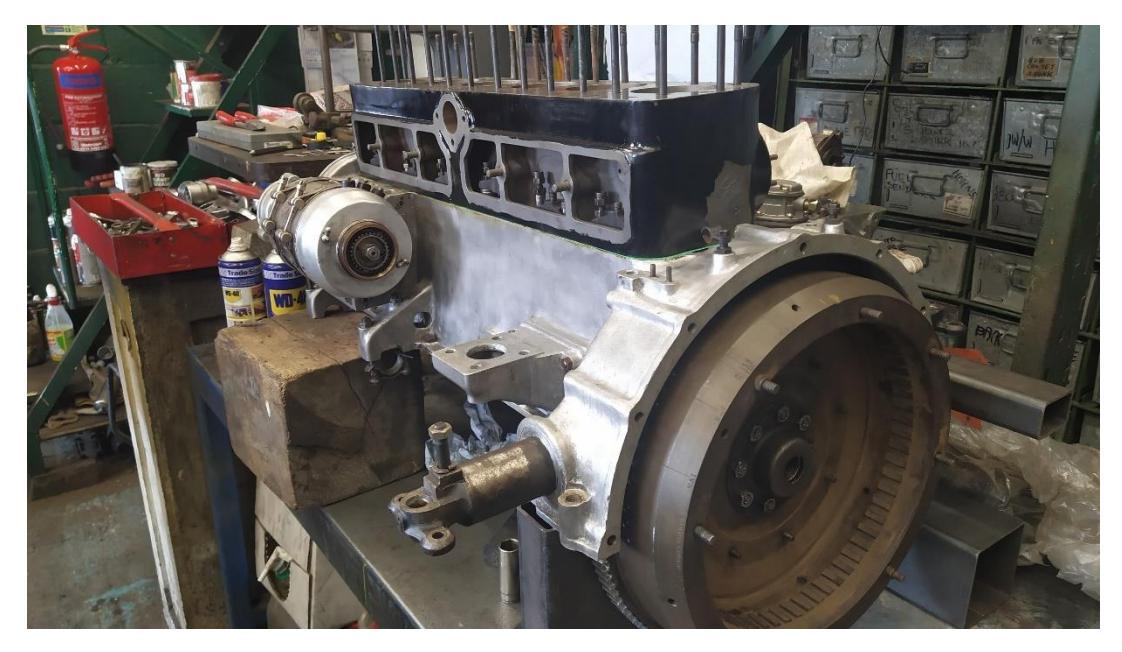
Rear view of the block lowered onto the crankcase.

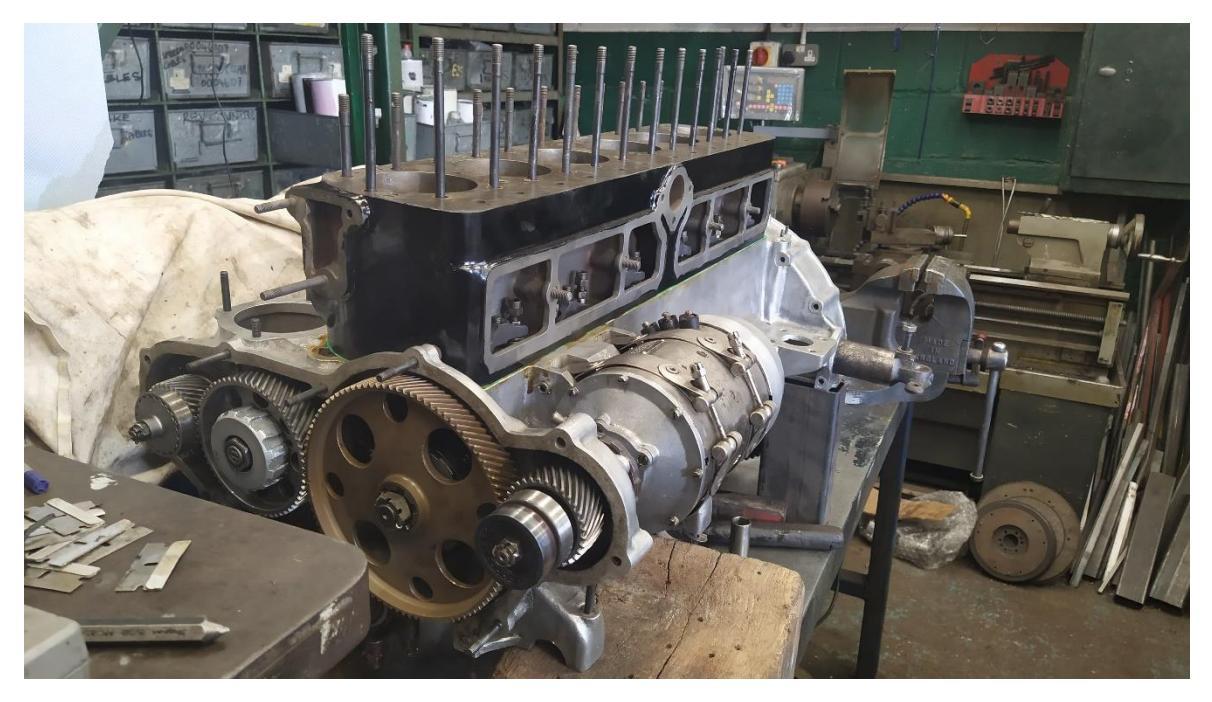
Frontal view of the block lowered onto the crankcase. It is here where one appreciates the physical depth of the engine.

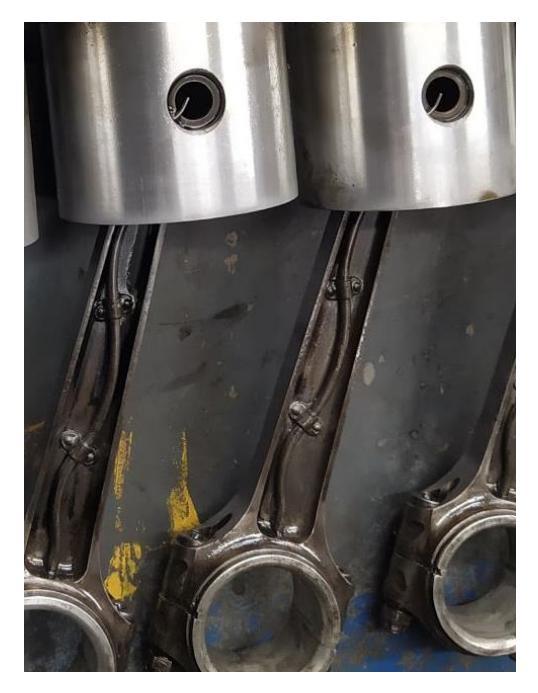
This wavy pipe is the oil pipe that delivers the oil to the little end of the piston. It is secured in 3 places with clamps that are riveted in position, and you must check that these rivets are secure. Once you know that this pipe is clear, you must ensure that all of the oil cavities in the con rod are clear. Finally, you should pressurise the pipe and ensure that air does not leak from it, otherwise you will need to rectify this here.

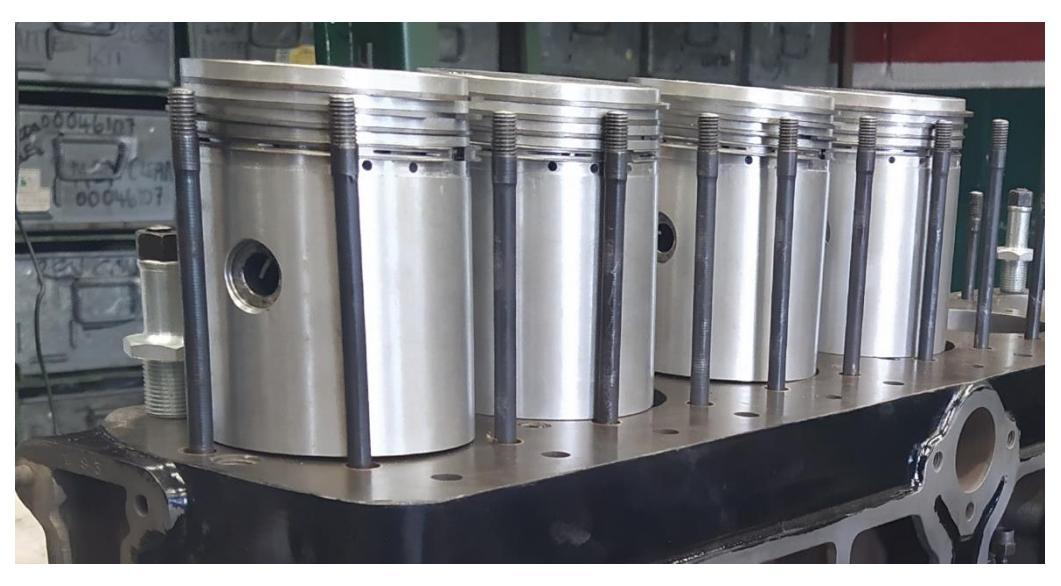
The pistons resting on the bores. Notice how the drilled holes all face towards the camshaft side of the engine. Note the depth of the pistons, this assists with the enormity of the torque that this engine produces.

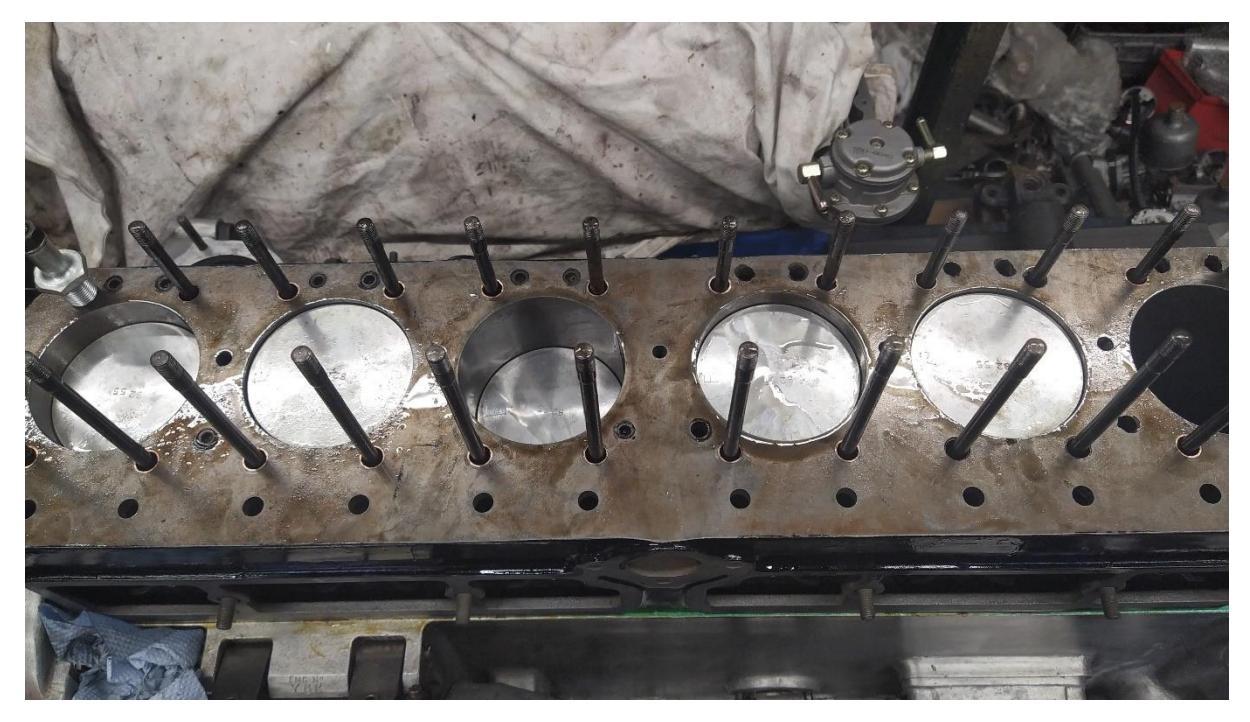
The view of the fitted pistons within the cylinders, a real sense of progress was felt here.

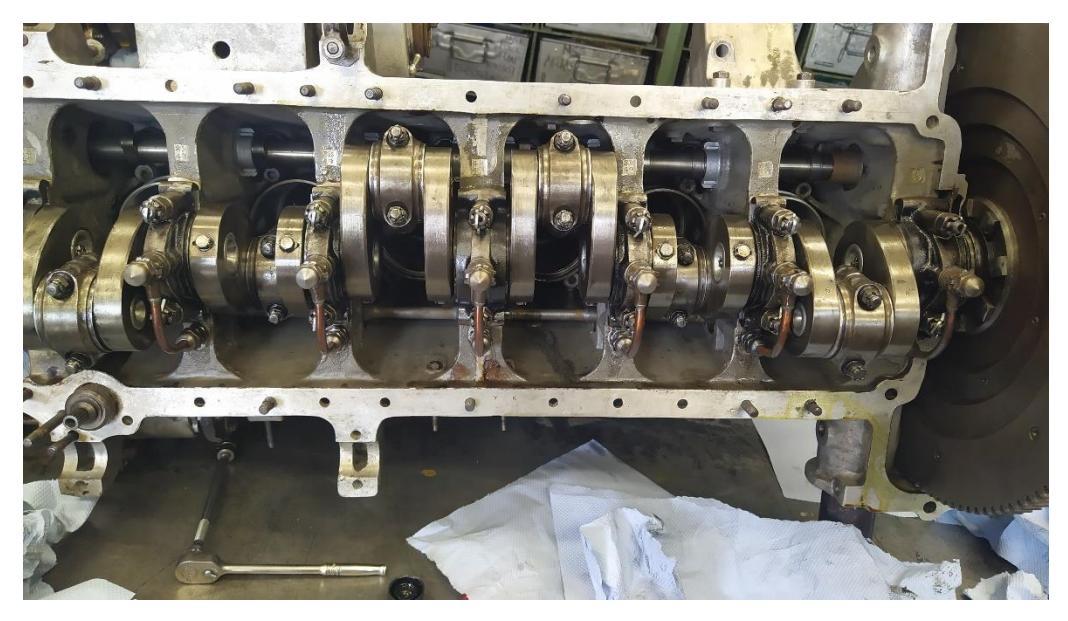
All conrods secured onto the journals. Notice the small socket drive we used, to avoid overtightening the bearings.

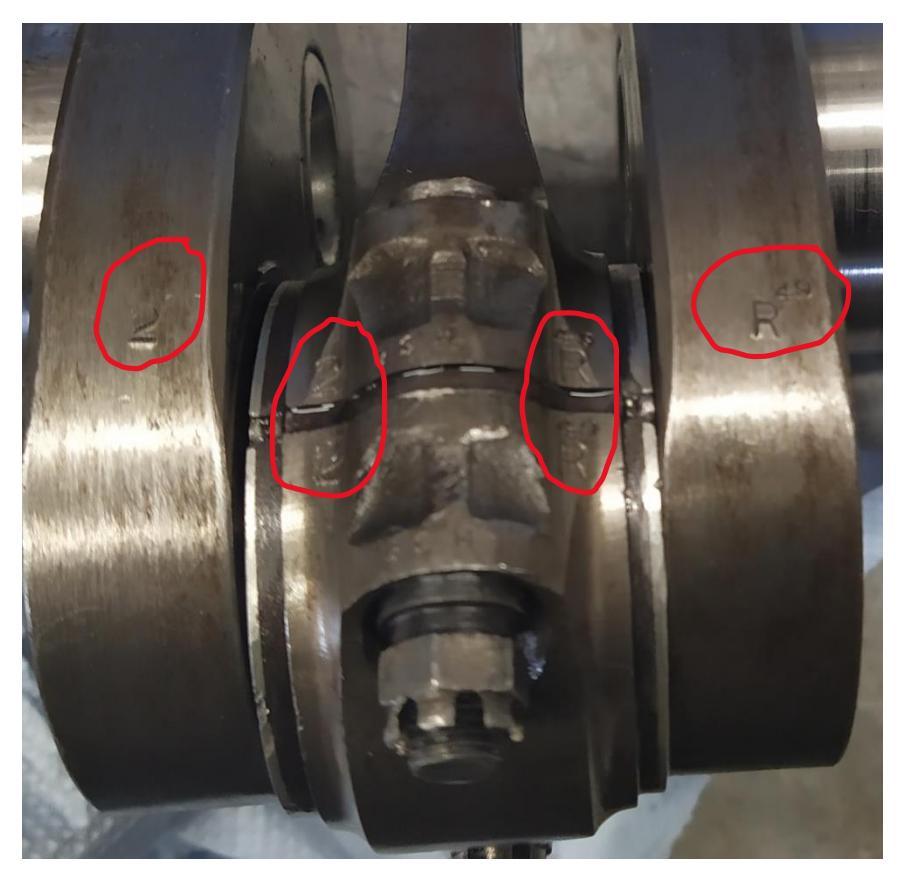
You can just make out that all the stamped number '2's are facing upright. Circled for clarity.

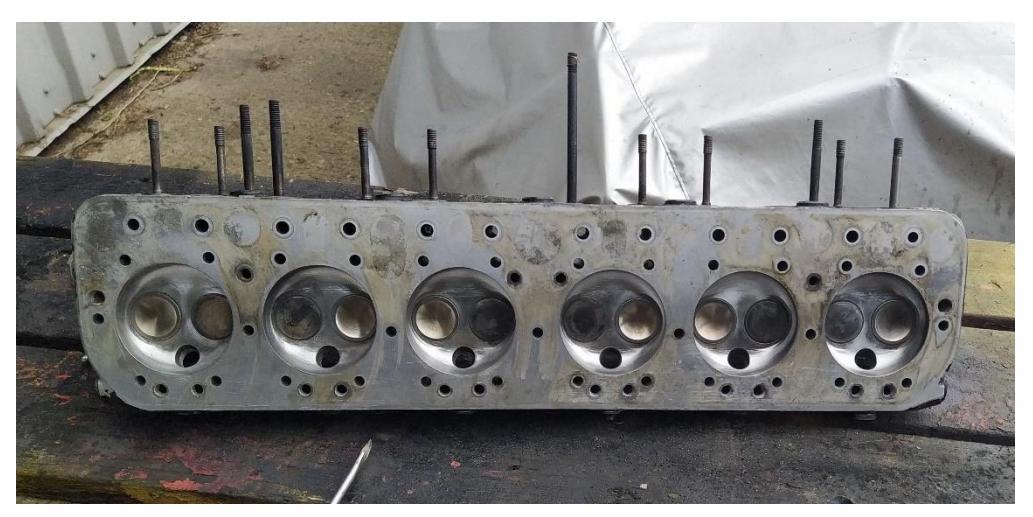
After!: The larger valves with the slight depression are the inlet valves, and the smaller valves are the exhaust valves. These have been changed in the past to run on unleaded fuel, but it is a safe option to run with a lead replacement additive.

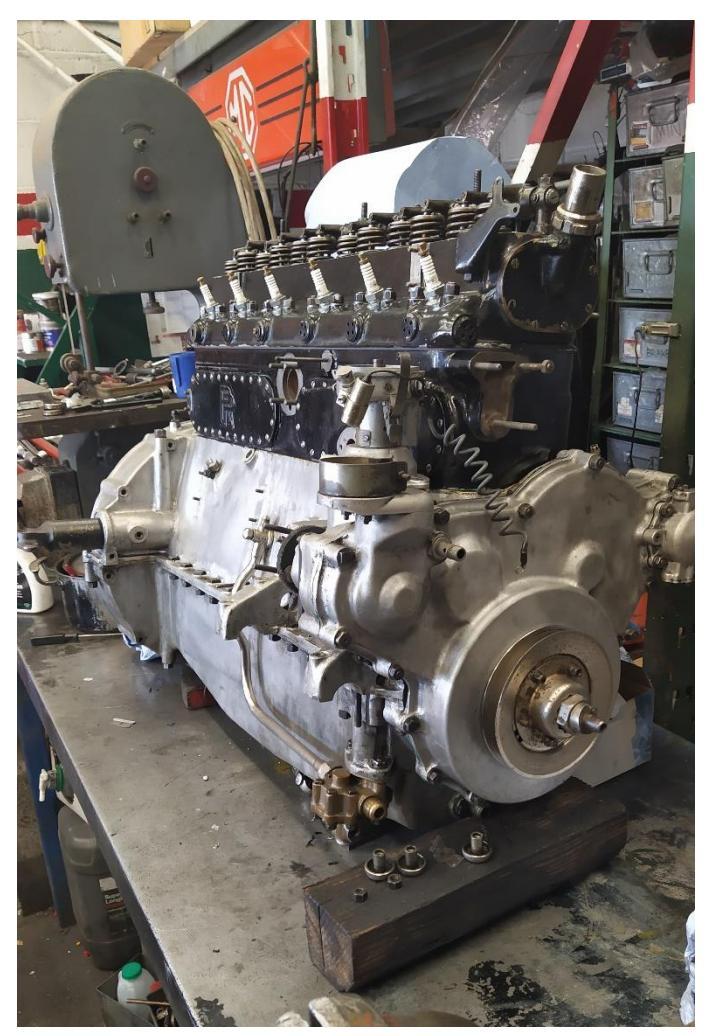
The finished engine ready to go back into the chassis. We placed the spark plugs into the apertures to stop contaminants entering the cylinders.

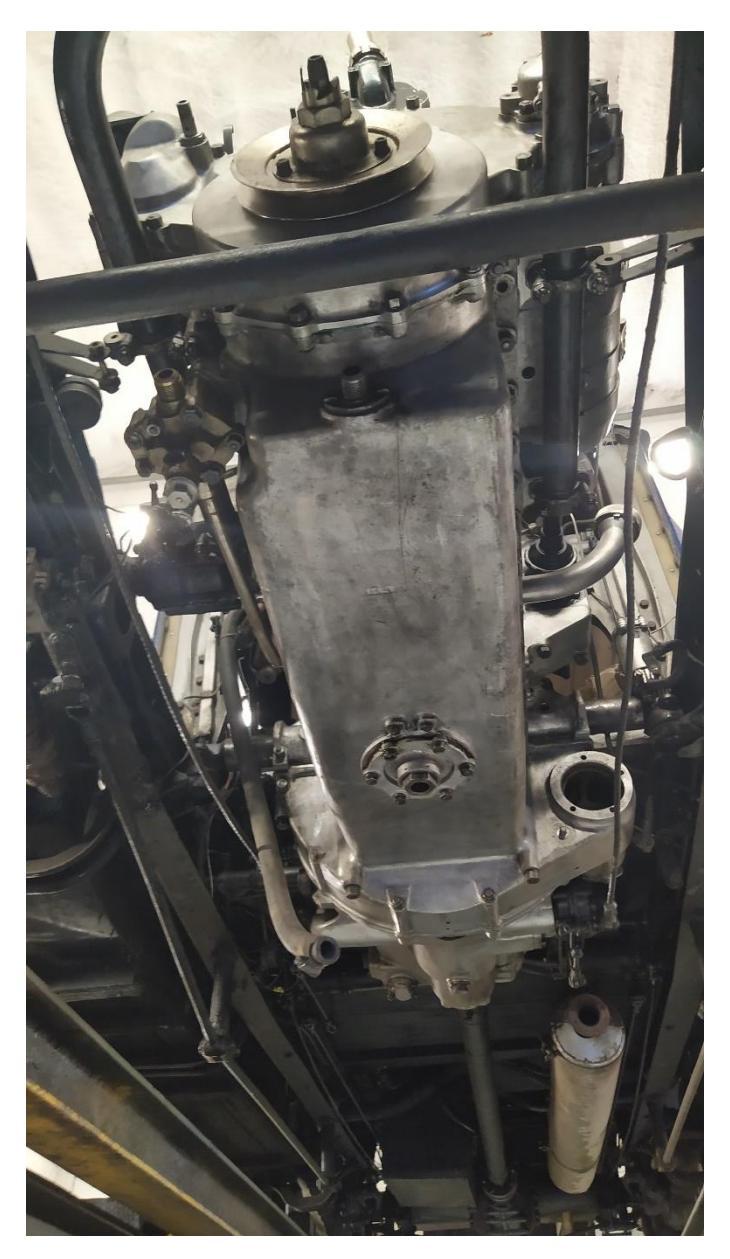
View from underneath the car; it looks so uncluttered which is the beauty of the Royce design

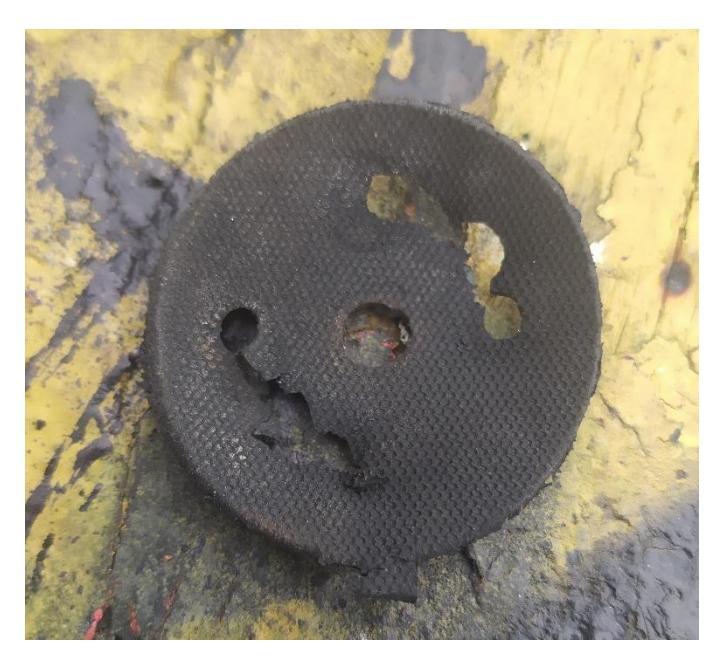
Rubber and ethanol do not mix! The ethanol infused petrol sat on the rubber gasket and literally dissolved the rubber rendering the tap useless; a big fire risk!

Brim the tank with fresh petrol, and ensure that the Autovac tap has its full range of movement. Use 92 RON petrol, and use a suitable ethanol stabiliser to protect your fuel system, otherwise your fuel tap will look like this:

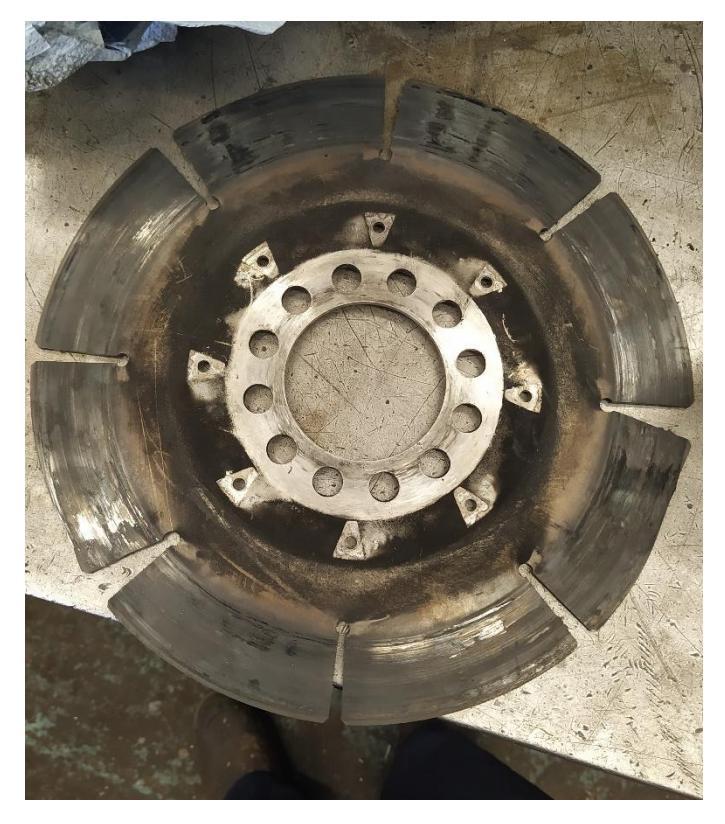
Evident on this clutch disk is a supreme amount of soot, most likely from the linings starting to burn. Further, the gaps between the segments are far too large and irregular, caused by extreme distortion. The plate itself is very thin indeed and has a tendency to develop hairline cracks beneath the segment gaps, so be aware of this.

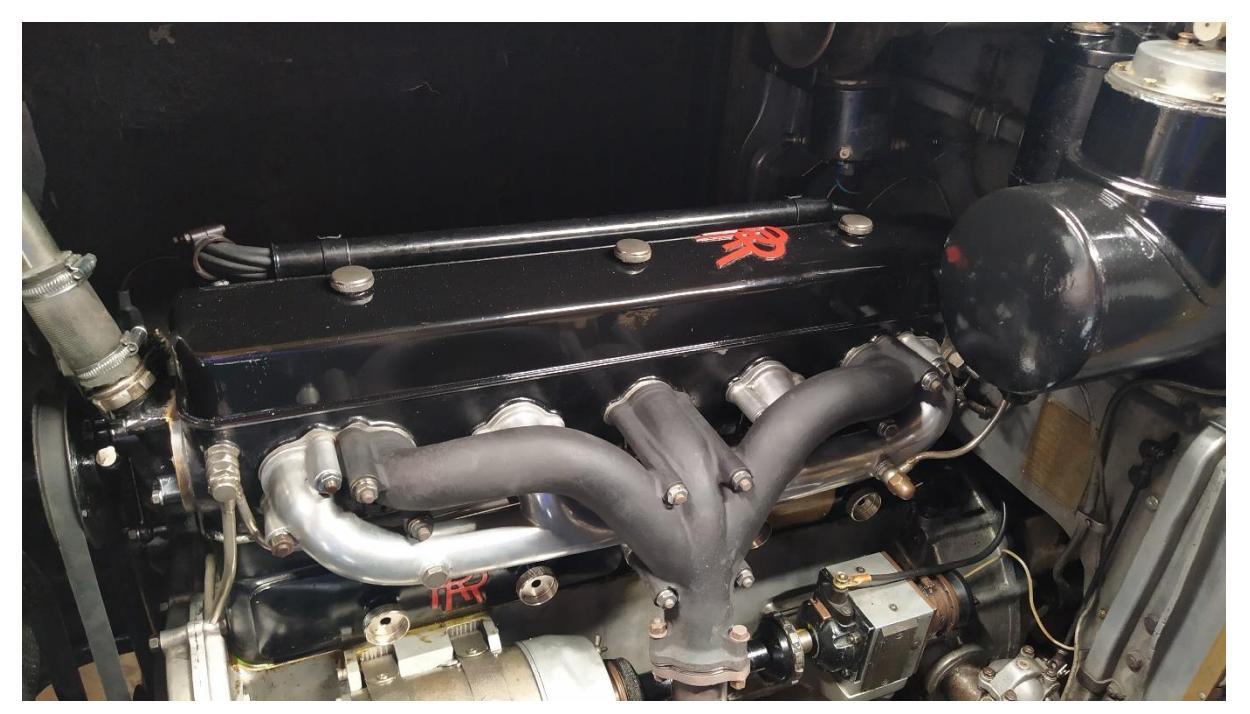
I painted the RR logos red in keeping with the experimental theme of the engine. It has much higher compression than a standard 20/25 engine and I like the caddish look that it gives; a statement of ultimate power.

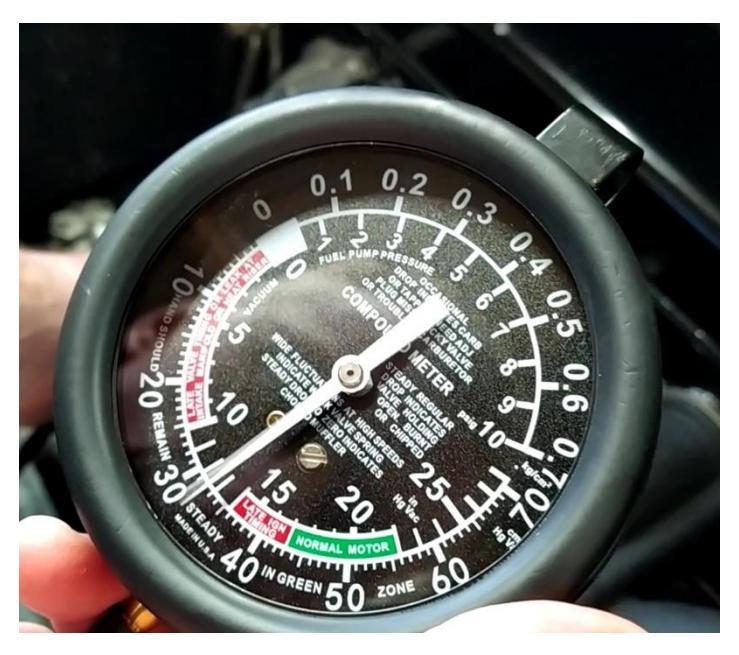
The vacuum gauge in use. As the valve timing was incorrect at the time of use, the white gauge needle was flickering at 13 inches of mercury during engine idle at 500 rpm.

Ideally, the engine needs to idle with a vacuum of 20 inches of mercury, and when you depress the throttle, the gauge should flick to zero vacuum then briskly ascend to approximately 25 inches of mercury, before returning to 20 inches of mercury at idle again. You are looking for the needle to hold itself steadily in the 'green' zone. If the gauge needle fluctuates, either rapidly or slowly, there is a fault with the mechanical system that needs addressing.
